**DATA COLLECTION SURVEY
ON
DISASTER RISK MANAGEMENT
IN
CARICOM COUNTRIES**

FINAL REPORT

JAPAN INTERNATIONAL COOPERATION AGENCY

NIPPON KOEI CO.,LTD.

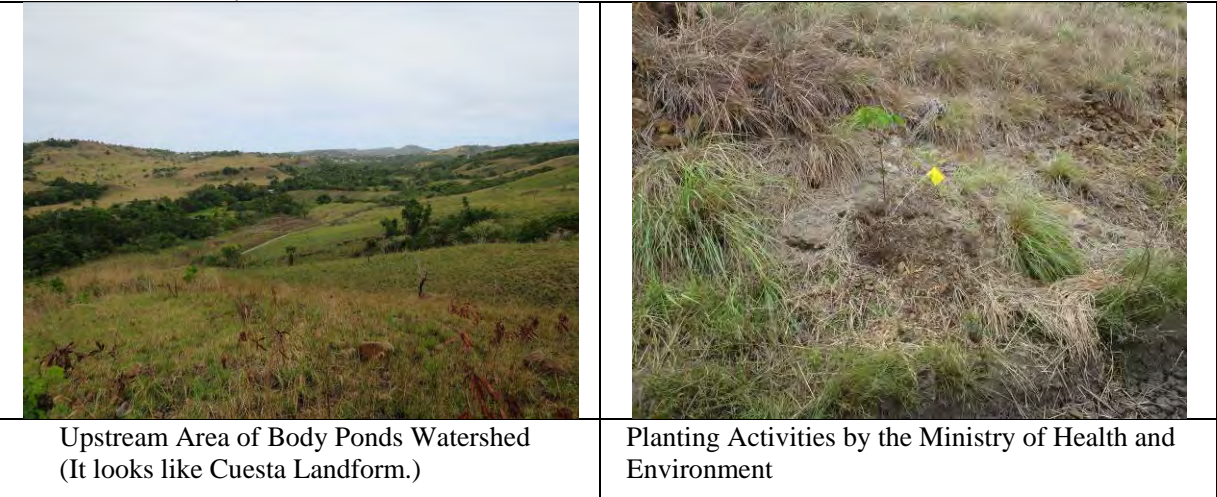
Figure 2.1.9 Upstream Area of Body Ponds Watershed

The Body Ponds Watershed with an area of about 4,000 ha is located in the Central Plain Zone. Precipitation water of heavy rain is concentrated in the watershed thereby causing inundation disasters in the Bendals area in the downstream part of the watershed. Sediment discharge is an issue in the Body Ponds Watershed that is followed by the abovementioned surface water flow. As a countermeasure against the sediment discharge issue, planting activities were started by the Ministry of Health and Environment recently on the slopes where uncovering is ongoing. No observation has been made on the effect of the planting on sediment discharge control. There is no definite watershed management plan. Figure 2.1.9 shows the upstream area of the Body Ponds Watershed, where the sediment discharge is an issue, and planting activities in the watershed. Figure 2.1.9 shows the situation in the Body Ponds Watershed.

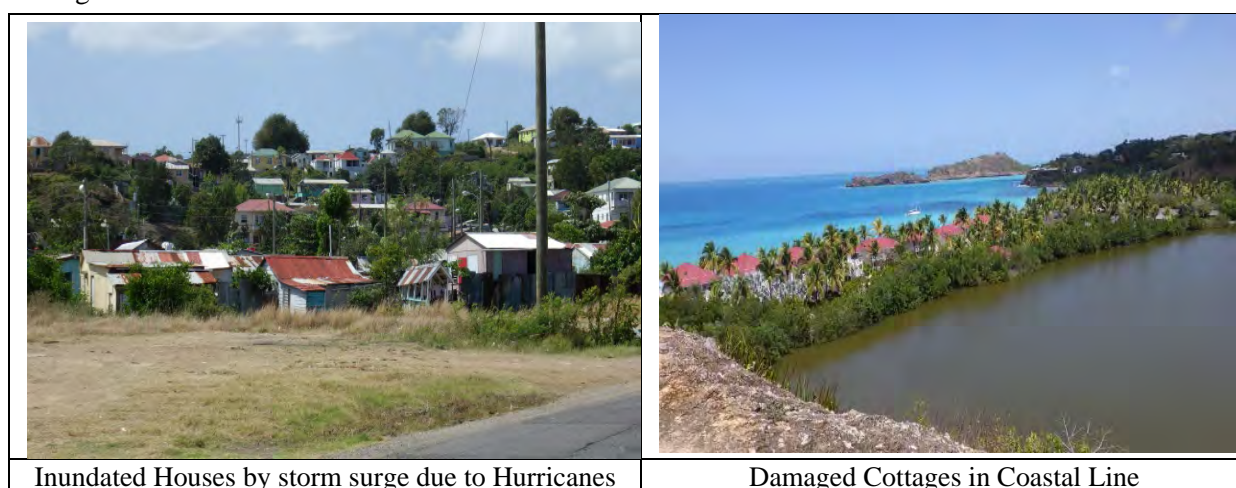
Figure 2.1.11 shows the damaged areas, in which houses and cottages exist, caused by storm surges in Antigua Island.

It is reported that storm surges during hurricane attacks have caused coastal erosion damages in Galley Bay in five island villages and beach in Landing Bay located in the western area of Saint John's. Moreover, the storm surges have spread over the main roads running in the east-southeast area resulting in damages to houses. The damages have been restored already.

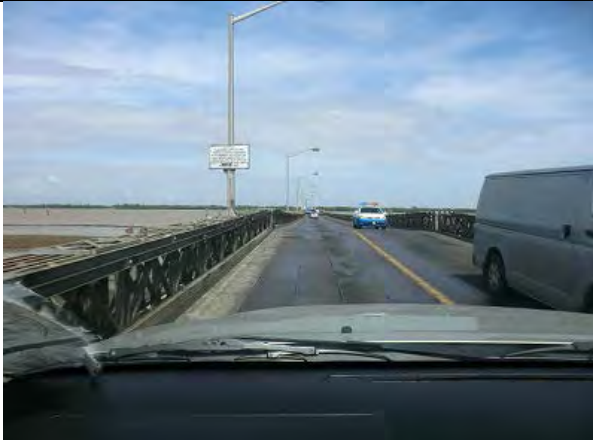
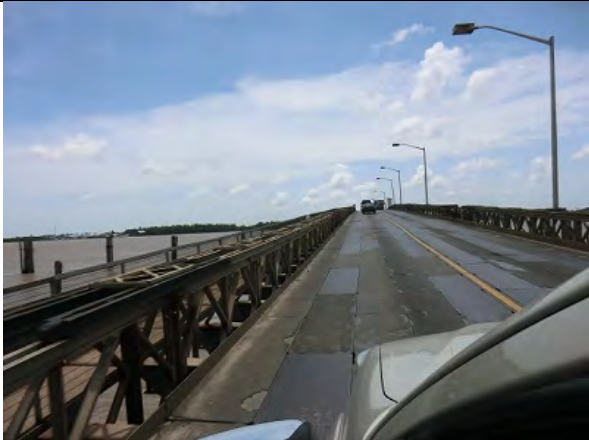
<p>Date : March 20, 2015 Site : Near bridge entrance Outline : Bailey truss girder, 36 m span</p>	<p>Date : March 20, 2015 Site : Uphill slope part Outline : O&M of steel floor slab required</p>

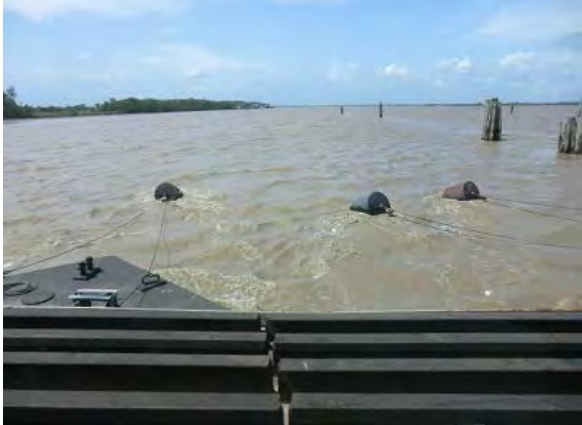
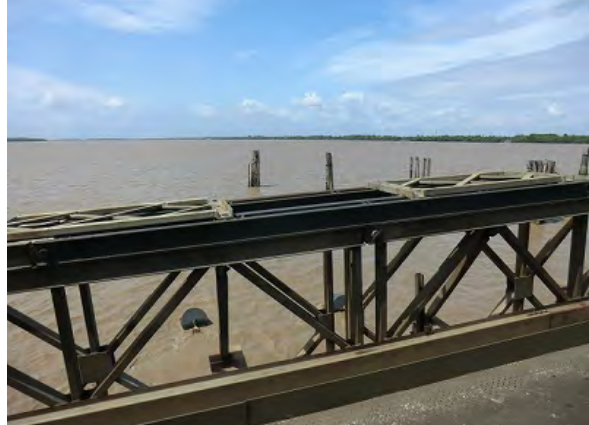
<p>Date : March 20, 2015 Site : Pontoon and its sign buoy of anchor</p>	<p>Date : March 20, 2015 Site : Bailey truss girder situation Outline : Double girder is applied</p>

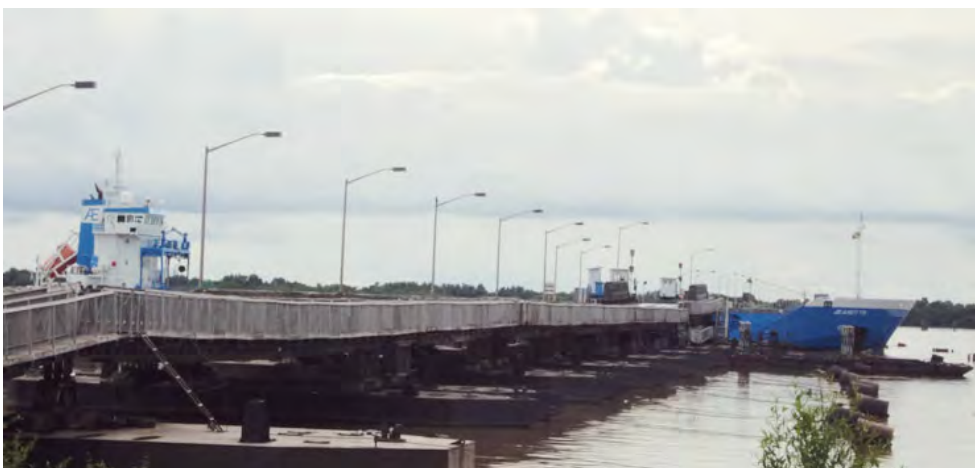
<p>Situation of pontoon : Ends of Bailey truss are fixed as hinge</p>

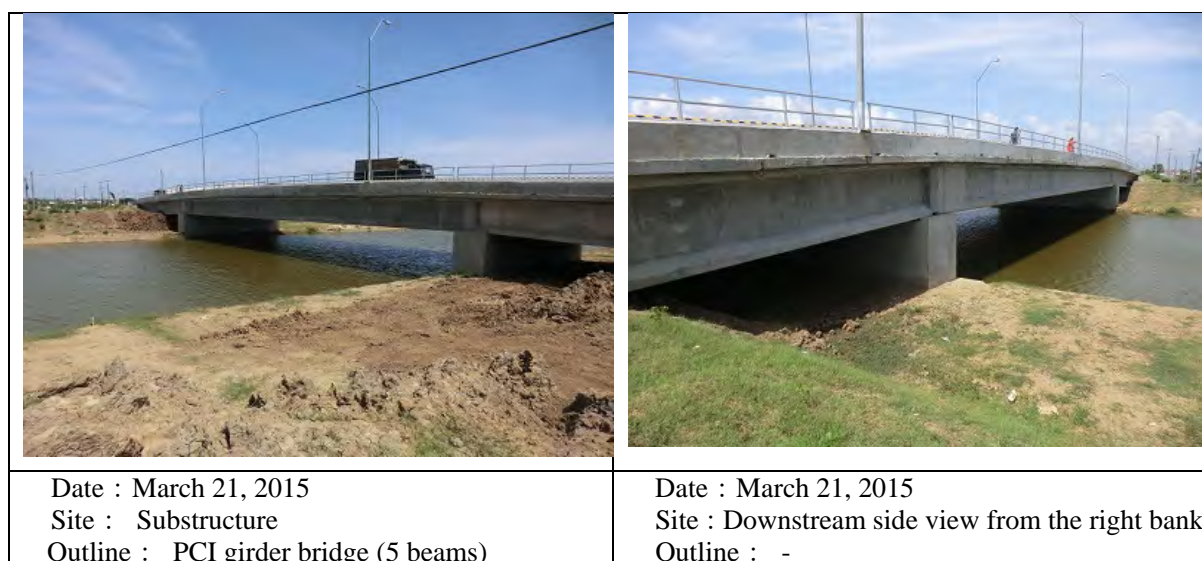
The new bridge was completed in February 2014 across the new canal (Hope Canal) which was constructed to increase drainage capacity of the Demerara Conservancy. Present view of the Hope Canal Bridge is presented in Figure 2.2.13.

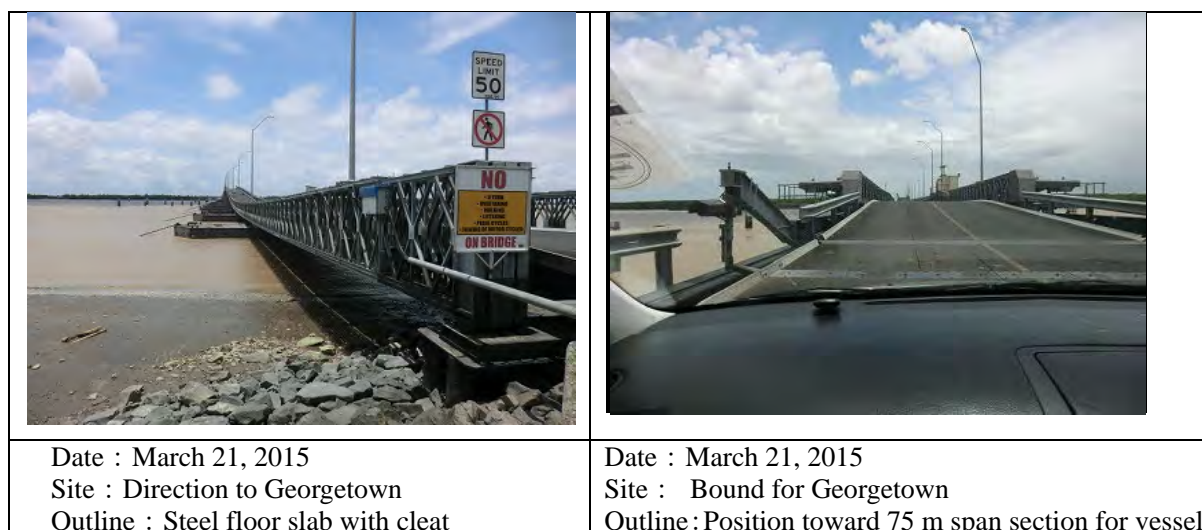
Figure 2.2.14 Berbice Bridge

The Berbice Bridge is a similar pontoon type bridge to the Demerara Harbour Bridge across the Berbice River nearby New Amsterdam, whose construction was completed in December 2008. The length is 1,570 m, which is the sixth longest in the world as a pontoon type bridge. A 70 m wide span is secured for a large ship (vessel) with an electrically movable span, while a 35 m wide span and 11.9 m clearance is always secured for small ship. The bridge is owned by the Berbice Bridge Company at present and to be transferred to the Guyanese government in 2035. Present view of the Berbice Bridge is presented in Figure 2.2.14.

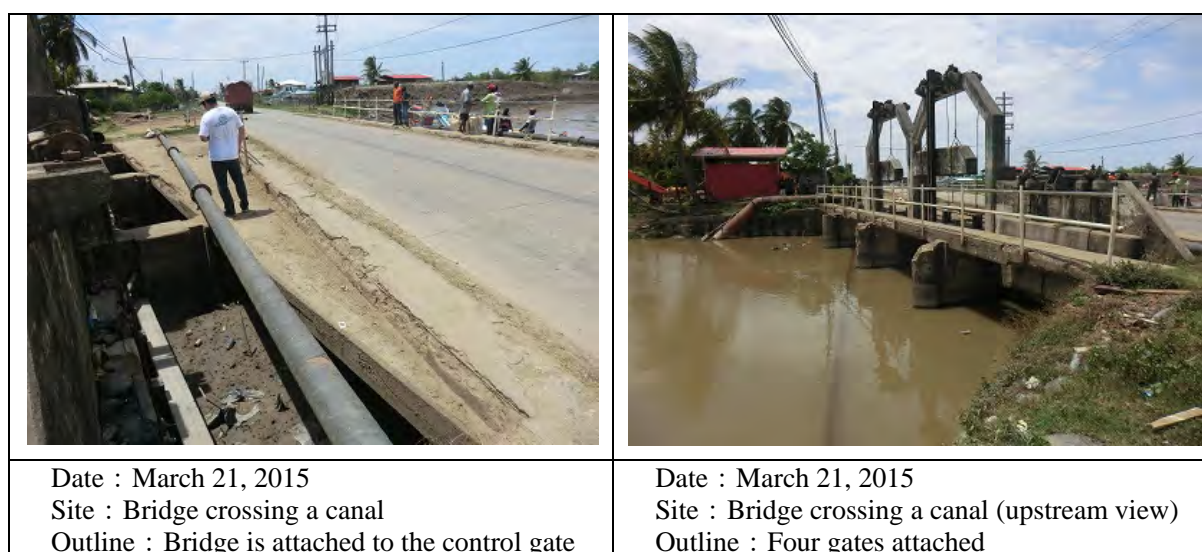
Figure 2.2.15 Bridges in Naivil Village

There is a bridge with four spans of concrete slab with 20 m length attached to the control gates on the Corentyne Coast Road across an irrigation canal near Naivil Village (41 km far from New Amsterdam).

There are several bridges similar to this bridge. View of the bridges in Naivil Village is presented in Figure 2.2.13.

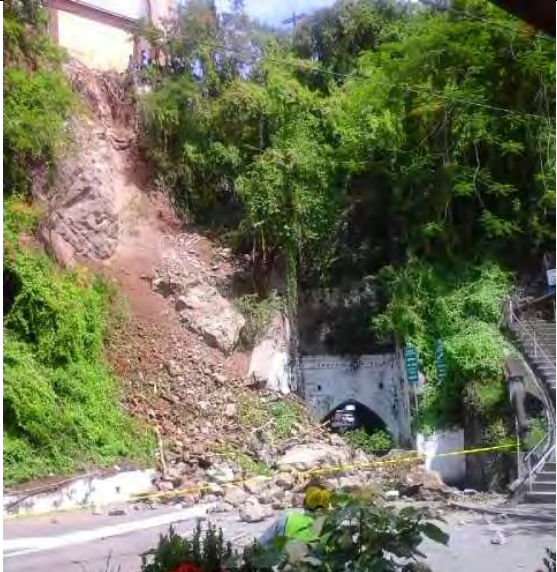
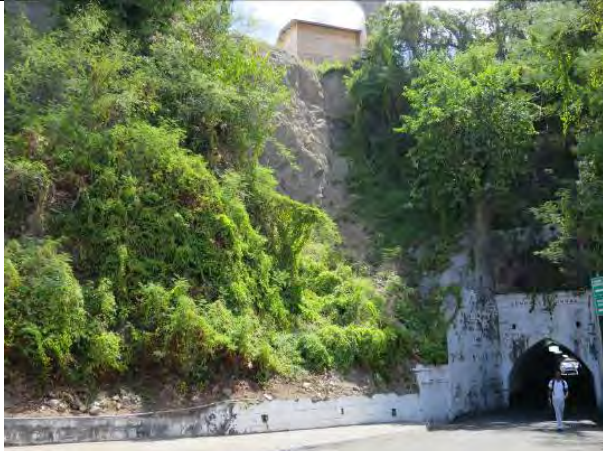
A 15 m wide slope beside the entrance of the Sendall Tunnel constructed in 1895 in St. George's collapsed due to heavy rains in September 2014 as shown in Figure 2.3.7. The upper area of the damaged slope is a historic place for tourism, having heavy traffic. The stability and protection works for the damaged slope will be carried out under the Regional Disaster Vulnerability Reduction Projects (RDVRP), whose budget of EC\$2 million (equivalent to about US\$740,000) is financed by the World Bank. According to the Ministry of Communications, Works, Physical Development, Public Utilities, ICT and Community Development, the project is in the stage of procurement for construction, as of March 2015.

<p>(The stability and protection works for the damaged slope will be carried out under the World Bank's RDVRP.)</p>
<p>Source: http://www.weefimgrenada.com/newsimg/Sendall-Tunnel-Slide-Day.jpg</p> <p>Slope Collapse at the Entrance of Sendall Tunnel in September 2014 (View right after the collapse)</p>	<p>Source: JICA Study Team</p> <p>Condition of Slope at the Entrance of Sendall Tunnel as of March 2015</p>

A 15 m wide slope beside the entrance of the Sendall Tunnel constructed in 1895 in St. George's collapsed due to heavy rains in September 2014. The upper area of the damaged slope is a historic place for tourism, having heavy traffic. The stability and protection works for the damaged slope will be carried out under the Regional Disaster Vulnerability Reduction Projects (RDVRP) financed by the World Bank.

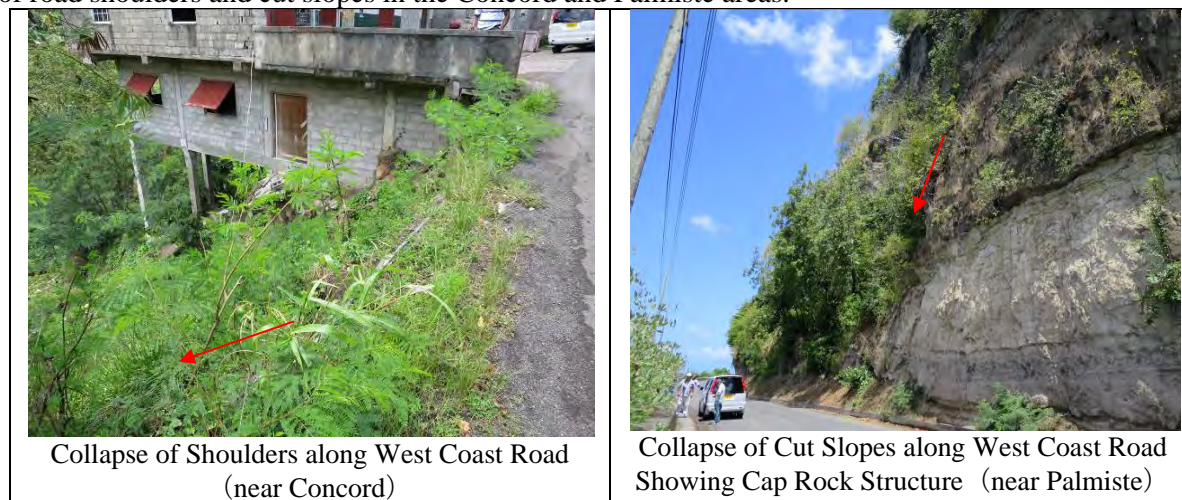
and Palmiste areas have been identified as vulnerable to disasters and are recognized as priority areas for improvement works in the Grenada National Hazard Mitigation Plan 2006. Figure 2.3.8 shows collapses of road shoulders and cut slopes in the Concord and Palmiste areas.

The West Coast Road running between St. George's Town and Victoria is rolling with steep cut slopes. Protection works of the slopes are few, so that many damages are observed on the road shoulders and cut slopes including rock falls near Concord. In particular, slopes near Palmiste have cap rock structure composed of softer tuff overlaid by hard lava, and larger sized collapses are also observed.

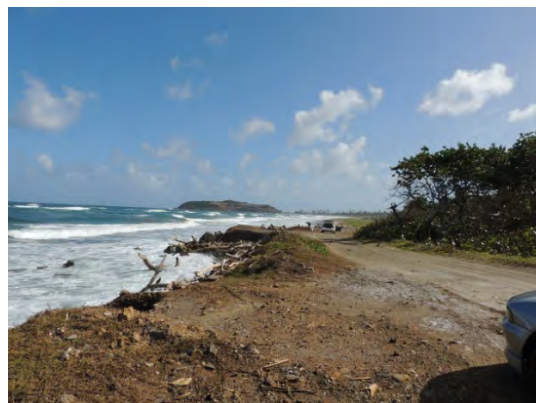
It was also observed that some erosion of the coasts were progressing due to the waves in the Great River Bay located at the northern part of Grenville on the eastern coast as shown in Figure 2.3.12. This area was recognized to be prone to wave actions.

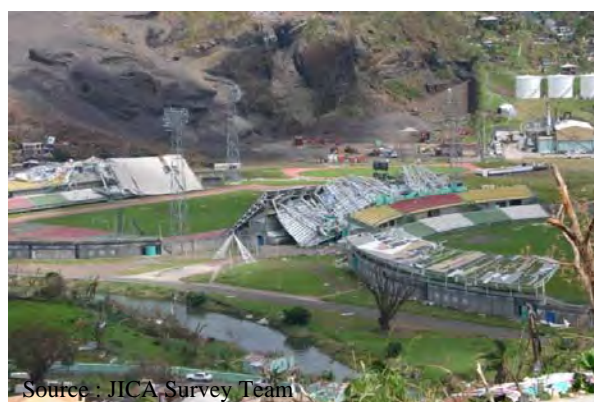
The disasters caused by hurricane are explained in the previous Item (2): Flood. As mentioned in this item, large-scale destruction of houses is supposed to be due to strong winds. Figure 2.3.13 shows the damage of the national stadium in St. George's caused by the strong winds of Hurricane Ivan.

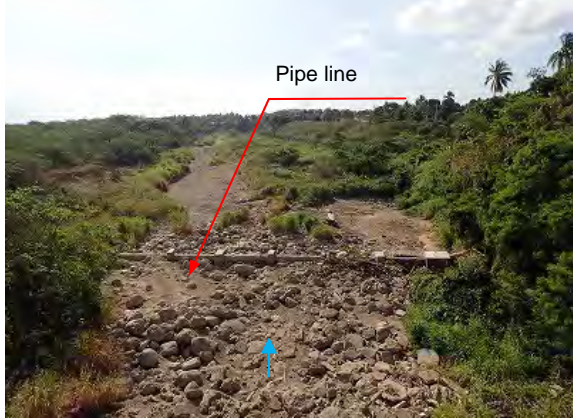
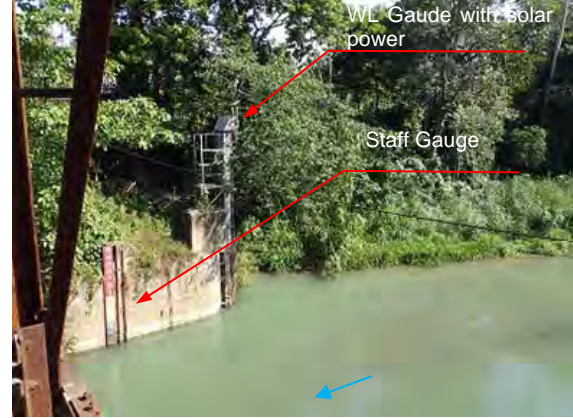
<p>Date : March 29, 2015 Site : Rio Cobre River, Spanish Town Bridge Outline : It is <i>wadi</i> in dry season like rivers in the southeast area. The pipeline crossing the river functions as ground sill. (Source: JICA Study Team)</p>	<p>Date : March 29, 2015 Site : Rio Cobre River, Bog Walk Bridge Outline : A water level gauge and staff gauge are installed at the upstream of the right bank, which are managed by WRA. (Source : JICA Study Team)</p>

Along the Rio Cobre River flowing down in the west of the metroplitan area, flood damages have frequently occured in road inundation as well as flat bridges on mountain streams. According to the National Works Agency (NWA), the countermeasure and improvement plan had been formulated previously but was cancelled due to the review of regional comprehensive traffic network.

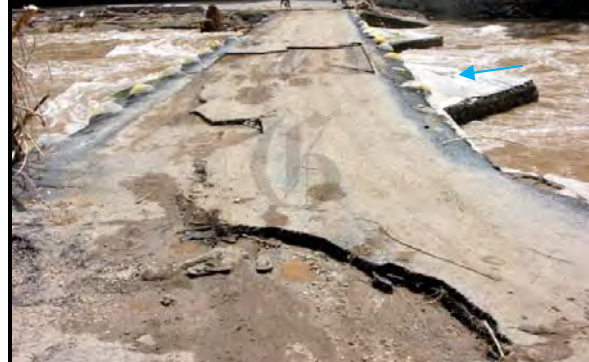
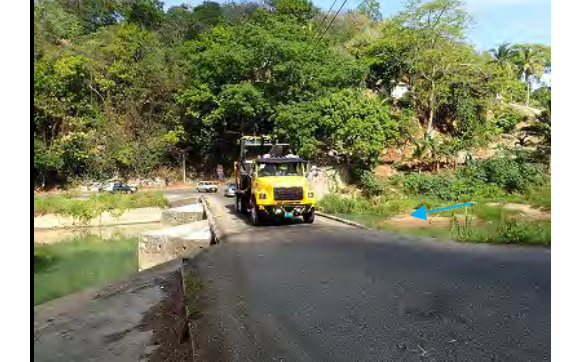
<p>Date : 2008 Site : Rio Cobre River, Flat Bridge Outline : Flat Bridge damaged by the flood in August 2008. Restored every time when it is damaged. Source: http://go-jamaica.com/blog/2008/10/09/bog-walk-gorge-before-and-after-gustav/gorgeb20080831ng/</p>	<p>Date : March 29, 2015 Site : Rio Cobre River, Flat Bridge Outline : Flat bridge located in upstream reach of the dam head. The bridge has a single lane with masonry abutment which is durable for overflowing. (Source: JICA Study Team)</p>

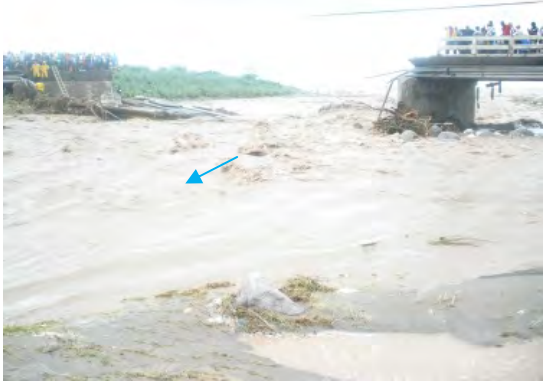
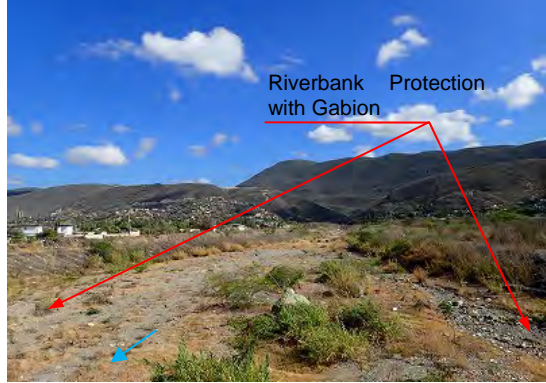
<p>Site : Hope River at Harbor View Bridge</p> <p>Outline : Photo of the bridge that was washed away during Tropical Storm Gustav in October 2008.</p> <p>After a temporary bridge for three years, the new bridge was constructed in 2011 with IDB support. It is said that abutment and piers were unstable due to riverbed degradation caused by active riverbed mining.</p> <p>Source : http://sflcn.com</p>	<p>Date : March 28, 2015</p> <p>Site : Hope River at Harbor View Bridge</p> <p>Outline : The Hope River is <i>wadi</i> in dry season. Riverbed material is composed of sand and gravel as well as boulder where large quantities of sediment have been transported. Gabion revetment was constructed on the riverbanks around the bridge when a new bridge was constructed.</p> <p>Source : JICA Study Team</p>

The Hope River, the Bully Bay River, and the Yallahs River in the southeast area are subflow rivers during the dry season. Bridges on the trunk road crossing these rivers were damaged or washed away previously by floods and sediment flows; replacement and/or rehabilitation of such bridges have been in progress.

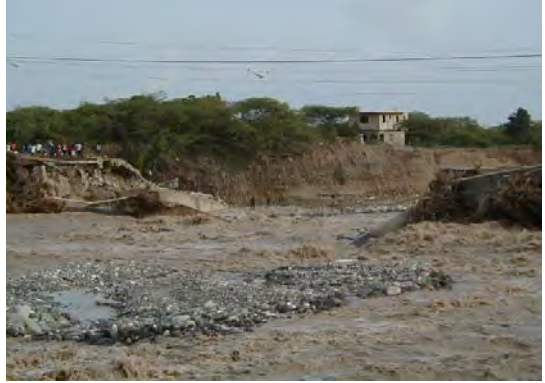
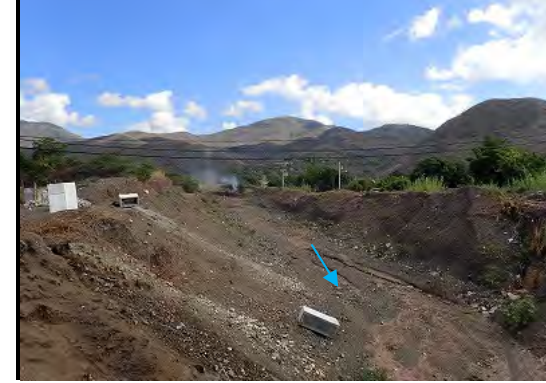
<p>Date : -</p> <p>Site : Yallahs River at Yallahs Bridge</p> <p>Outline : Photo of the Yallahs Bridge damaged during flood in October 2002. A new bridge was constructed under IDB Jamaica Development Infrastructure Project (JDIP) supported by IDB in 2011.</p> <p>Source: http://www.mona.uwi.edu/</p>	<p>Date : March 28, 2015</p> <p>Site : Bully Bay River at Bully Bay Bridge</p> <p>Outline : It is <i>wadi</i> in dry season and a large amount of sand and gravel is accumulated. River improvement by dredging was conducted by NWA without river banking. It is concerned that river bank would be severely eroded in the rainy season and dredged materials would flow into the channel.</p> <p>Source: JICA Study Team</p>

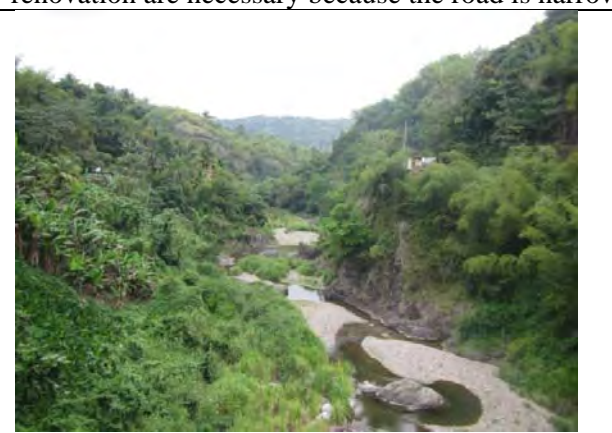
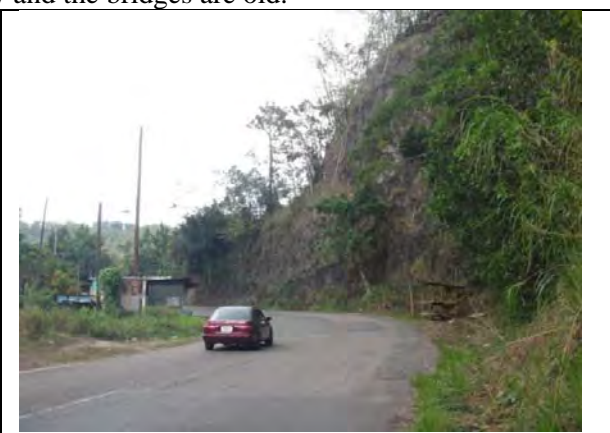
The said section, where traffic is heavy because it is the shortest route between Port Maria and Kingston, is running along the Wag Water River and suffering frequent falling rocks, slope failure, and landslide. Traffic stoppage due to sediment disaster has serious impact on logistics. In case of such traffic closure, the road is temporarily closed and is reopened only after removing the sediment, e.g., through symptomatic treatment when sediment disasters occurred as shown in Figure 2.4.11. In addition to slope stabilizations, comprehensive countermeasures including road widening and bridge renovation are necessary because the road is narrow and the bridges are old.

<p>Date: March 8, 2015</p> <p>Location: Stop 3: Route A3</p> <p>Description: Junction Main Road running along the Wag Water River has been constructed by cutting slopes along the river, but almost no slope stabilization works are performed.</p>	<p>Date: March 8, 2015</p> <p>Location: Stop 3: Route A3</p> <p>Description: There is no protective fence in steep cliff. Rock frequently falls and sediment outflows as well to the road. Traffic is heavy.</p>

The said section, where traffic is heavy because it is the shortest route between Port Maria and Kingston, is running along the Wag Water River and suffering frequent falling rocks, slope failure, and landslide. Traffic stoppage due to sediment disaster has serious impact on logistics.

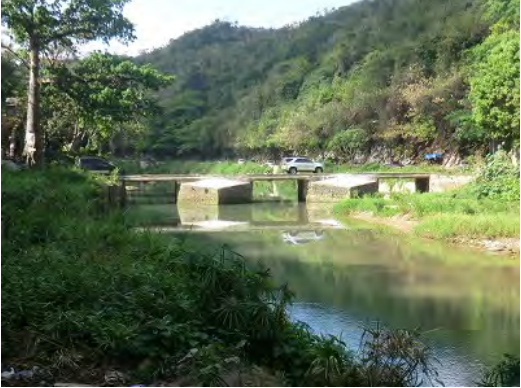
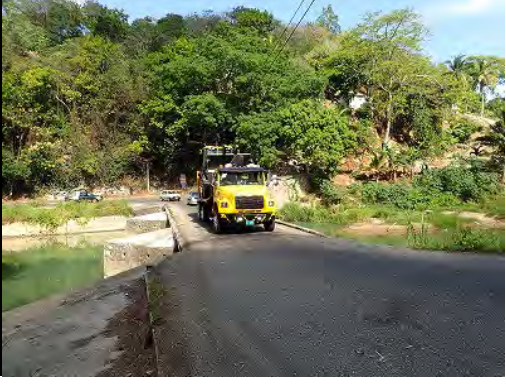
This flat bridge is located on the National Road A-1 connecting Kingston and St. Ann's Bat Rio via Moneague and crossing the Cobre River. The bridge is a submerged concrete slab type with two piers,

and is 25 m long and 3.5 m wide. Traffic on the road around this bridge is suspended due to inundation during every flood. The present situation of the Flat Bridge is shown in Figure 2.4.16.

<p>Date : March 29, 2015 Site : Rio Cobre River, Flat Bridge Outline : Submerged bridge with concrete slab with two piers; 25 m long and 3.5 m wide.</p>	<p>Date : March 29, 2015 Site : Rio Cobre River, Flat Bridge Outline : Alternate traffic with traffic signal at both sides.</p>

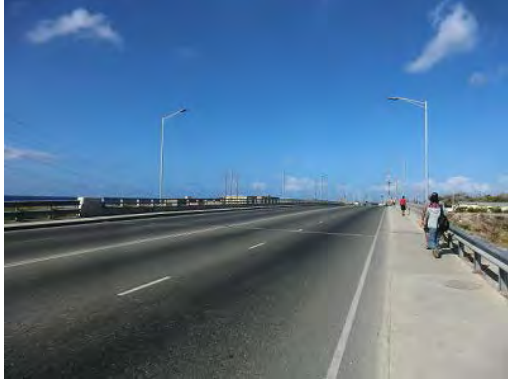
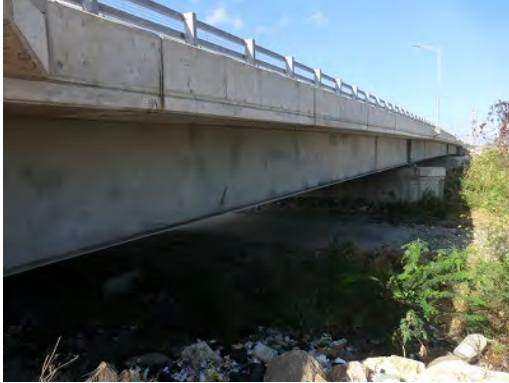
The Harbour bridge is on National Road A-4 crossing the Hope River. The bridge was totally washed away due to flood during Hurricane Gustav, and re-constructed and opened in November 2011 as shown in Figure 2.4.17.

<p>Date : March 28, 2015 Site : Harbor Bridge (A4) Outline : The previous bridge was washed away entirely due to flood caused by Hurricane Gustav in 2008. The present bridge was completed in November 2011.</p>	<p>Date : March 28, 2015 Site : Harbor Bridge (A4) Outline : No water was found in the channel of the Hope River. Upon flooding, water and much sediment flow down.</p>

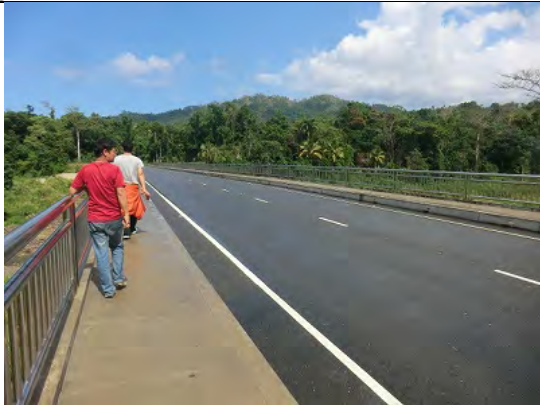
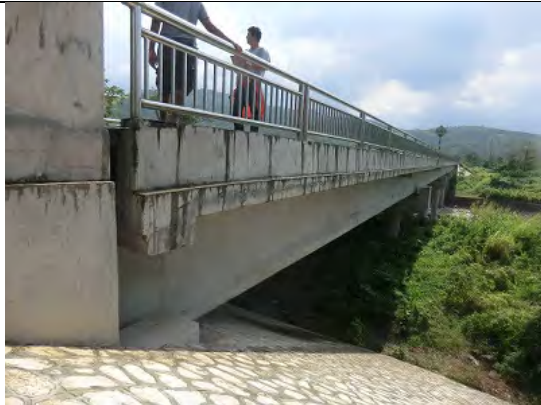
The Westmoreland Bridge is a bridge across the Wag Water River. It had been destroyed during Hurricane Gustav and reconstructed under Jamaica Development Infrastructure Project (JDIP) supported by China in August 2008. The present situation of the Westmoreland Bridge is shown in Figure 2.4.18

<p>Date : March 28, 2015 Site : Westmoreland Bridge Outline : Concrete Box Girder Bridge</p>	<p>Date : March 28, 2015 Site : Westmoreland Bridge Outline : Old bridge was left at downstream side.</p>

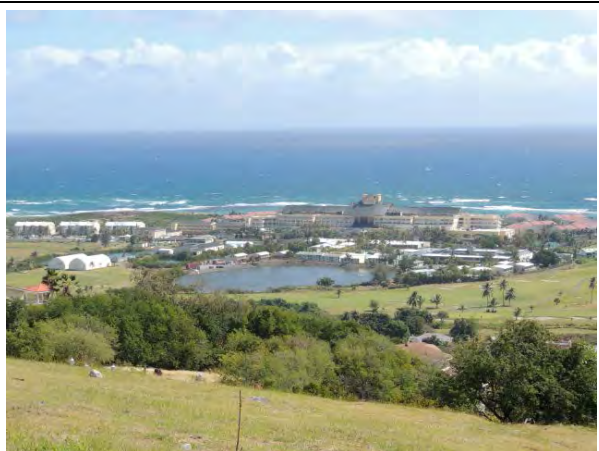
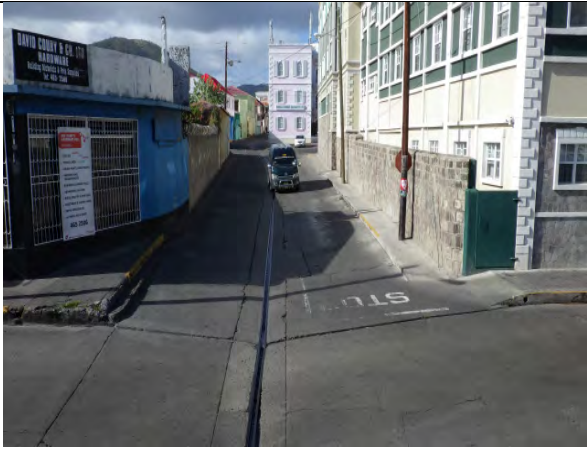
<p>Hotels located along the coastline, which are vulnerable to floods, storm surges, and tsunami</p>	<p>A road in Basseterre, which is used as a drainage as well (Domestic sewage is discharged through a small ditch, and flood is discharged using the full width of the road)</p>

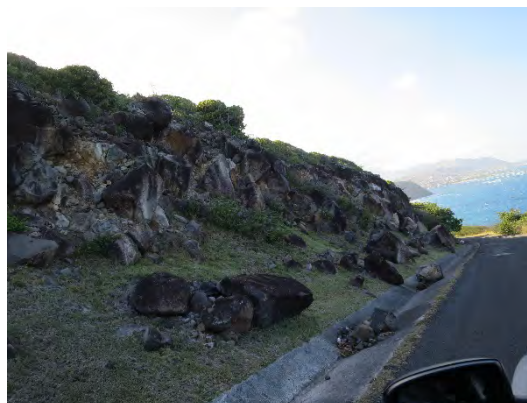
Figure 2.6.8 Rockfall from Slope of Road to South Peninsula

There is no major river in Saint Christopher and Nevis, but streams of 7-8 m wide run toward the coasts. The roads running around Saint Christopher Island pass over the plain land and no slope protection is made basically. The road section to the South Peninsula passes through steep sloped area, in which no slope protection is seen too. Some small-scale rockfall of weathered sand stones was observed in the section as shown in Figure 2.6.8.

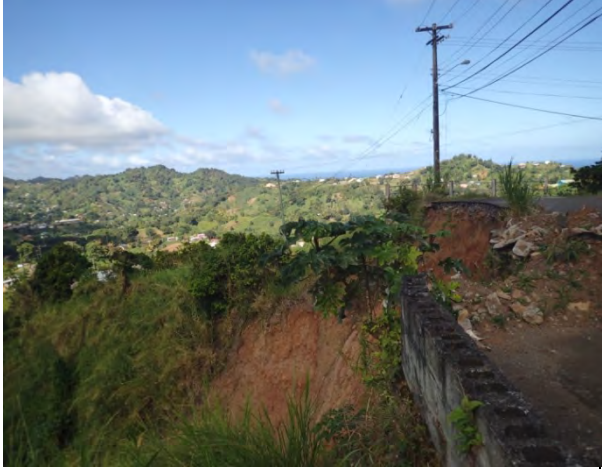
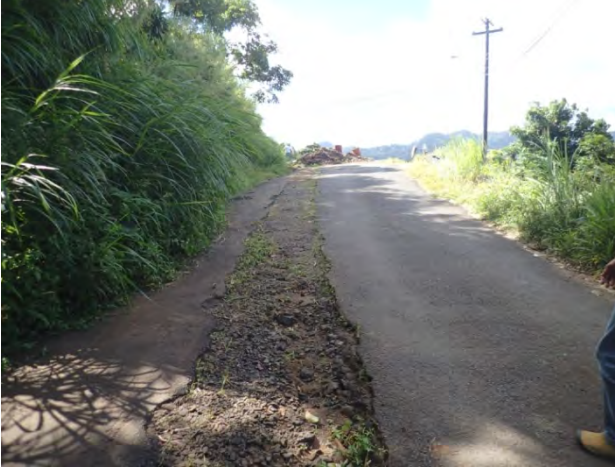
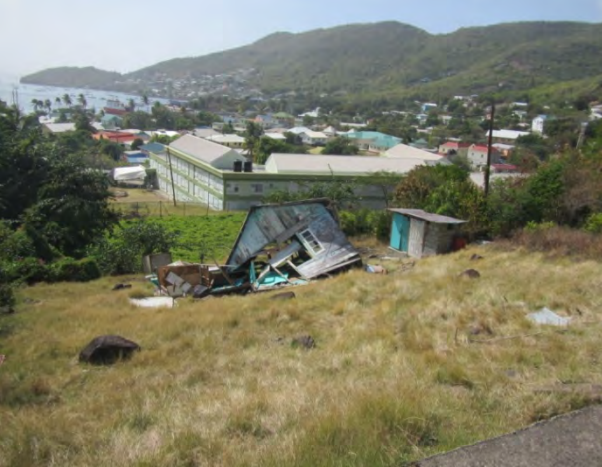
In Bequia Island, since many houses were destroyed by serious landslide damage caused by the heavy rains of Christmas trough in December 2013, the residents were forced to reconstruct, renovate, or transfer. The traces of landslides still remain everywhere such as collapsed house left as it was in Union Vale area as seen in the lower-right of Figure 2.7.8.

Date : March 8, 2015 Site : Stop 1: Windward Highway	Date : March 8, 2015 Site : Stop 2: Landslide site at Vigie Highway

Date : March 8, 2015 Site : Stop 2: Landslide site on Vigie Highway	Date : March 13, 2015 Site : Stop 3: Landslide site in the Bequia Island
