UNESCO-IPRED-RIHS INTERNATIONAL WORKSHOP
PADANG, INDONESIA, 6-8 JULY 2010

Research Institute for Human Settlements
Agency for R&D – Ministry of Public Works of Indonesia
Provincial Government of West Sumatera
Padang, Indonesia

SURVEYS AND ACTIVITIES ON POST-EARTHQUAKE DISASTER

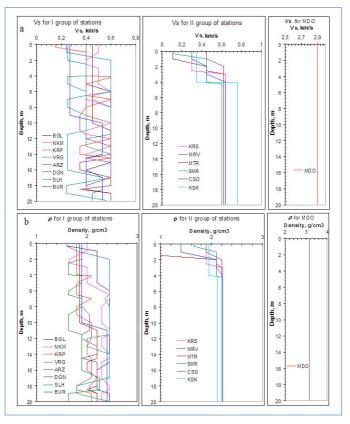
Figure 4 Variations in velocity Vs (a) and ground density (b) with depth in the upper 20 m layer under the station groups

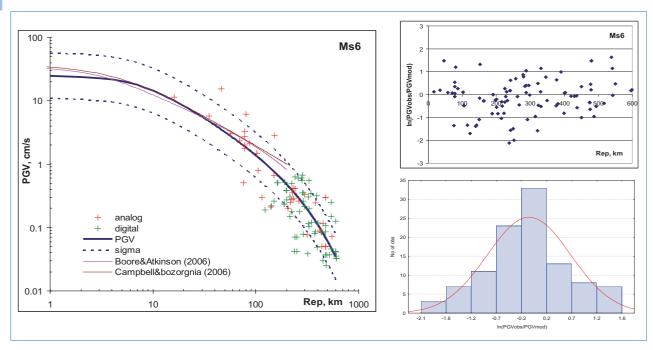
Figure 8 PGV attenuation model for 6 Ms and corresponding residual distribution and histogram

To obtain our own regional relations, an attempt was made to use strong-motion data together with data from other seismological networks in Kazakhstan (records of earlier local and regional analogue networks and records of regional network of digital velocigraphs). Such an approach enables PGA and peak ground velocity (PGV) attenuation relations to be obtaned in southeastern Kazakhstan for prediction ground motions in seismic hazard assessment and microzonation. As an example, Figure 8 shows the PGV attenuation model for Category II soil, based on complex data for the 6 Ms group, together with observed peak velocities, a corresponding residual distribution and a histogram.

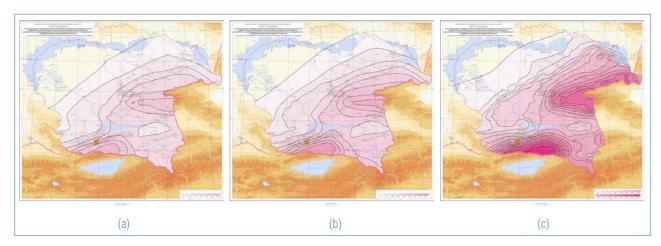
Figure 9 Peak ground acceleration maps for the Almatinskaya Oblast territory
The probability of intensity not exceeding calucations is:
(a) 90 per cent (b) 95 per cent and (c) 99 per cent, within 50 years

Attenuation relations obtained for earthquake-prone areas of Kazakhstan are an important part of seismic hazard assessment. They are used to obtain spatial distribution of peak ground acceleration in the territory of some administrative districts and Almaty City. As an example, Figure 9 shows probabilistic seismic hazard maps in PGA for the territory of Almatinskaya Oblast. Calculations are made for the bedrock level (Vs≥1,500 m/s) without considering the influence of sedimentary cover (Silacheva, 2010).

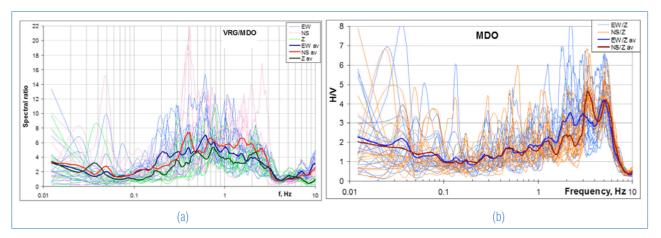
Figure 10 Spectral ratios (a) standard for the VRG station with respect to the MDO station, (b) H/V for the MDO station

Spectral analysis of network records enables empirical transfer functions to be obtained in the area of strong motion stations, and the city territory to be zoned with respect to the spectral characteristics of soils. For each station, the average spectral ratios of the Fourier spectra horizontal component over vertical are calculated and the average standard spectral ratios are obtained with relation to the reference MDO station located on the bedrock outcrop within the city. As an example, Figure 10a shows plots for the VRG station. The need to use both techniques is due to the imperfection of MDO as a reference station and the peculiarities of the basin in which Almaty is located (in the centre). From one side, the H/V ratio for MDO, averaged over all available events, shows amplification at frequencies of about 2–6 Hz (Figure 10b), probably due to topographic conditions or weathering of the upper rock layers. From the other site, in major cases both horizontal and vertical components of records are also amplified, changing the pattern of local amplification given by the H/V method. For all cases, there are complicated spectral ratios with amplification within the range of 0.2–3 Hz. The general level of amplification increases at the stations located on debris cones compared to the stations over the deepest part of the basin. A complicated form of empirical transfer functions and considerable amplification of vertical components may indicate the existence of 2D–3D effects in the Almaty area.

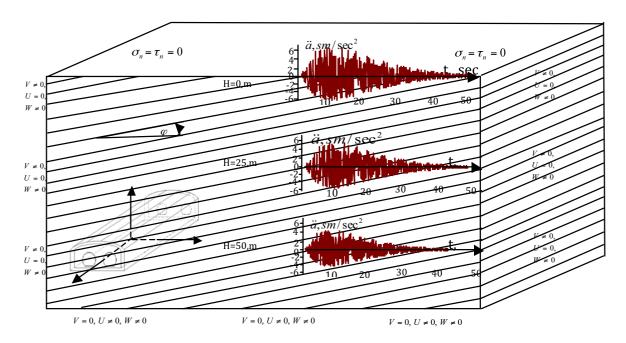
Figure 2 Equilibration region of a complex system of underground structures and synthetic accelerogram of a strong earthquake (intensity I = 10) for the rock massif from the surface to a depth of 50 m

Using the foregoing formulas (1g)–(1k) for the anisotropic massif, synthetic accelerograms will be generated, as shown in Figure 2.

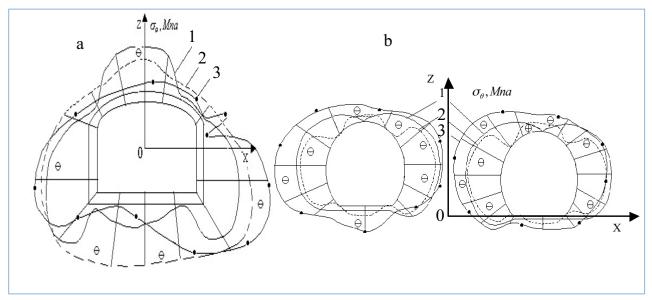
Figure 3 Diagrams of seismic boundary stresses of tunnels at different points of nonstationary seismic effect of 10-point earthquake: a) metro station with twin running tunnels; b) station section 22 metres from the exposed face; c) running tunnels section 35 m from the station. Curves correspond to: 1) static loading from the weights of upper massif layers yH, where y – bulk weights of the massif; 2) and 3) the time of seismic effect 18.244 s and 35.132 s as per accelerogram

The accelerograms generated for internal layers of the rock massif can now be analysed. Apart from cracking up to the land surface, the continuity of internal layers of the massif remains unaffected, so the same values should be obtained at all points within the massif. This is shown by the accelerogram at all depths up to 50 m (Figure 2). The underground structure will be laid depending on the depth in the rock massif. For the calculation of seismic boundary stress, respective accelerograms can be selected from the sets as an ixternal action. Figure 3 shows the seismic boundary stress diagram for the stationary and running tunnels.

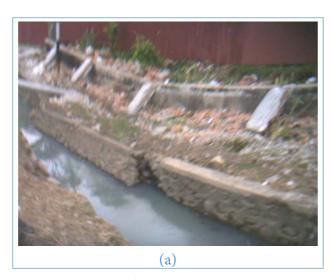
Figure 2 Liquefaction: (a) deformation of the soil layer due to the river wall breaking, Jl. Gereja, and (b) differential settlement of subgrade foundations

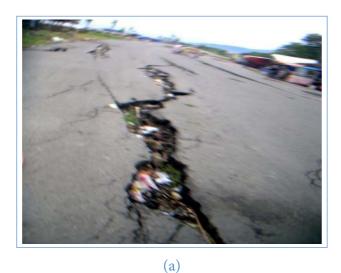
Figure 3 Liquefaction: (a) lateral movement causing a road to crack, Jl. Samudera, and (b) sand from the bottom of a road experiencing landslides, Jl. Samudera

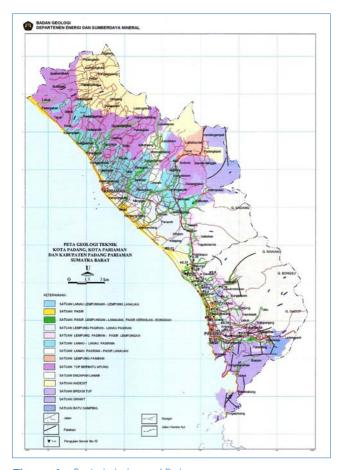
Figure 4 Geotechnical map of Padang

In general, the geology formation of the town of Padang and the surrounding area consists of sedimentary rocks, volcanic intrusive rocks and alluvial deposits. In parts that have slightly sloping morphology or low-lying areas, such as Minangkabau International Airport (S. Prawiradisastra et al, BPPT), most deposits are alluvial: loose deposits, composed of silt, sand and gravel.

Level land to the south and east of Padang Municipality is extensive multicycle alluvial, composed and fluvio-volcanic deposits consolidated with lava, volcanic tuff and andesite, generally covered by a layer of Pleistocene coarse sand 5–10 m thick. Along the coast of Padang in a north-south direction, there are deposits of silty sand with a thickness of 1.5–6 m.

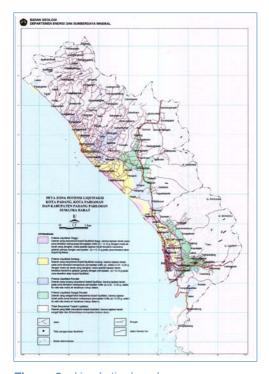
Figure 6 Liquefaction hazard map

After the 30 September earthquake, the Geological Agency conducted soil tests and made a zoning map of liquefaction potential in the vicinity of the city and along the west coast of Padang Pariaman. The mapping results indicate that some areas of Padang City and its region that have a high potential for liquefaction, such as Ulak Karang. Tabing and Ganting showed moderate results, while Kubu is among the very low potential areas (Figure 6). These results were very close to the mapping that existed before the earthquake in 1997. For example, the previous map shows Padang and Ulak Karang as having high liquefaction potential, Ganting moderate potential, and Kubu very low potential.

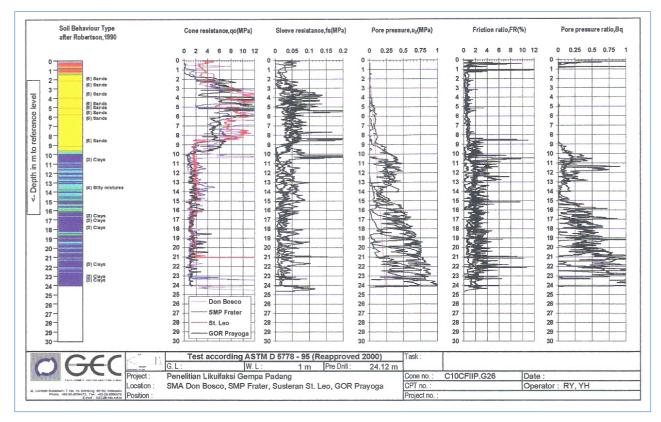
Figure 7 CPTU test results

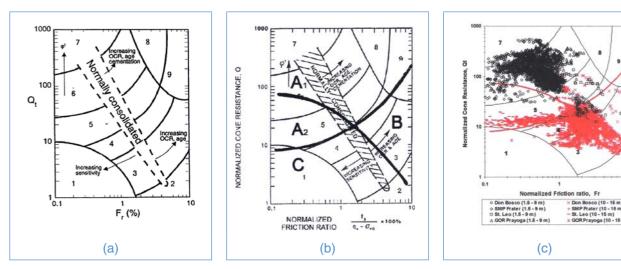
Figure 8 Robertson Chart (Robertson, 1990): (a) soil behaviour, (b) liquefaction identification, and (c) plotting data

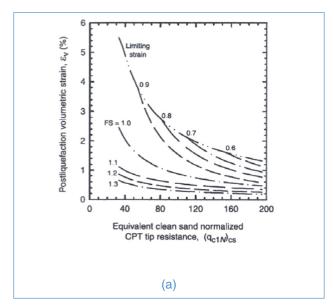
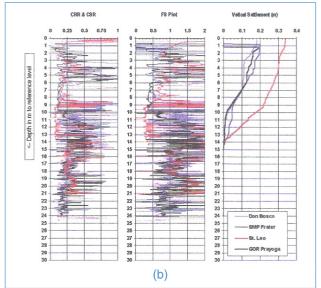
Figure 9 Chart (Zhang et. Al, 2002) and settlement evaluation: a) relation of volumetric strain post liquefaction and normalization cone tip, and b) the result of settlement calculations

The predicted settlement was 20 cm at Don Bosco Senior High School, Frater Junior High School and GOR Prayoga, while the visible settlement was approximately 34 cm at St. Leo Convent.

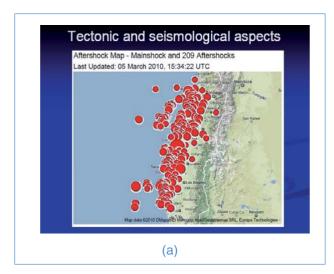
Figure 2 (a) Aftershock map, and (b) tsunami effect in the Pacific Ocean

A week after the earthquake, more than 200 aftershocks had been registered in the affected area, some of which had a magnitude of around 7 Mw (Figure 2a). The post-earthquake tsunami hit the Chilean southcentral coast hard, and its effects could be seen over almost the entire Pacific Ocean (Figure 2b).

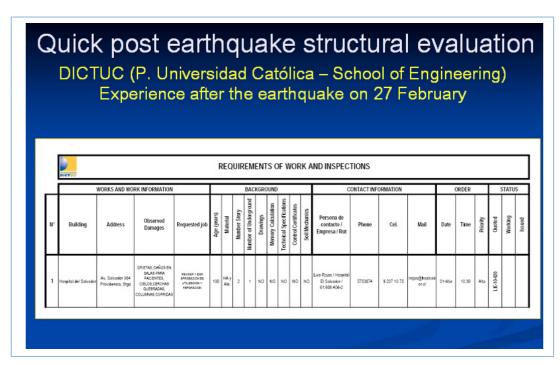
Figure 7 Process of recovery from earthquake disaster (Building Research Institute)

To determine the order of actions, the process of recovery chart of the BRI (Building Research Institute) was used as reference. In this way, DICTUC participated in the Quick Inspection and Detailed Inspection process.

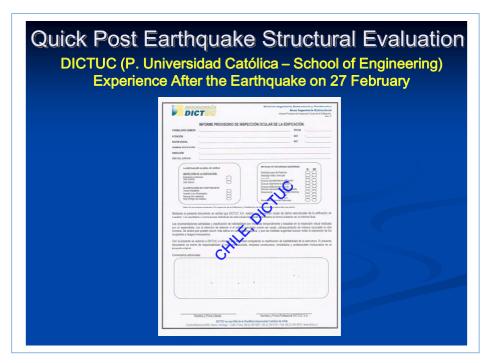
Figure 10 Provisional report for inspected buildings

For the buildings visited, a provisional report was made (Figure 10), specifying its safety condition (habitable, restricted access, uninhabitable or dangerous), and immediate actions required to make the building safe (underpinning, demolishing elements, removing coatings, evacuating the building, etc.)

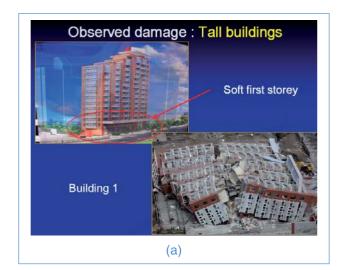
Figure 13 (a) Collapsed building with soft first storey, and (b) building with partially collapsed soft intermediate storey

Typical damage observed to high-rise buildings was due to the presence of soft storeys, both in the first level, and intermediate levels, including stiffness change in height.

Figure 13a shows the only tall structure experiencing total collapse due to earthquake. This building had a double height soft first storey, which is very common in Chilean construction. Figure 13b shows an intermediate soft storey collapse, without total collapse of the building. Both buildings are in Concepción City.

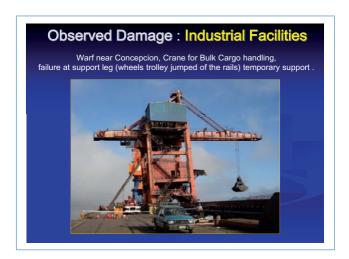
Figure 24 Crane on a warf near Concepción with failure of the support leg

Figure 24 shows a crane for bulk cargo handling on a warf near Concepción, with failure of the support leg and a large angle of inclination.

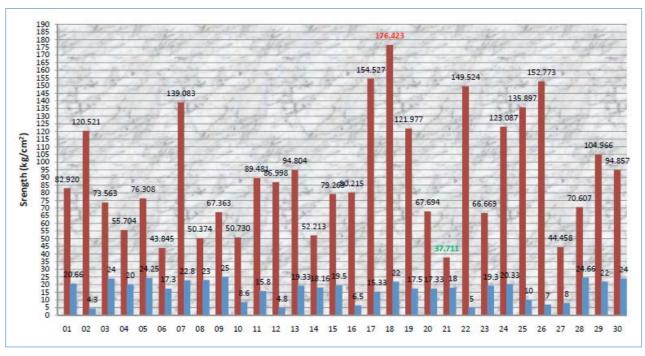
Figure 3 Results of compression testing for concrete from 30 locations in Manado City

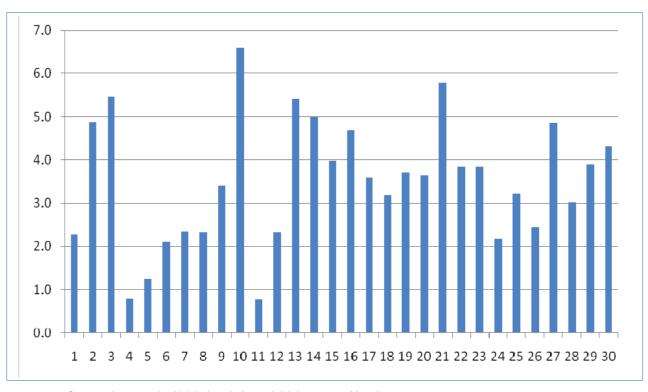
Figure 4 Compression strength of bricks bought from a brick factory near Manado

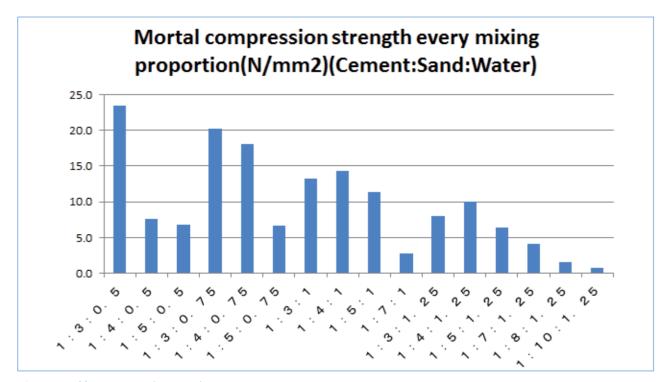
Figure 5 Mortar compression strength

Mortar should be mixed in a 1:4 ratio, which is perhaps enough strength for brick accumulation. The results of compression testing of mortar carried out in Manado Politeknik University are shown in Figure 5.

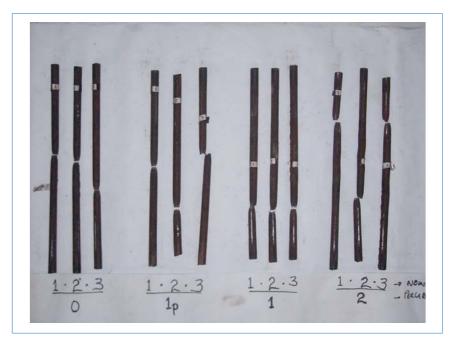
Figure 1 16 mm diameter samples after testing

The failure point tends to occur in regions grappling of bent reinforcing steel and towards the middle (not the clips) in unbent reinforcing steel, as shown in Figure 1. This failure occurs because the cross-section steel is bent and straightened his strength increased, whereas the cross sections near the clamps are unbent and lower in strength.

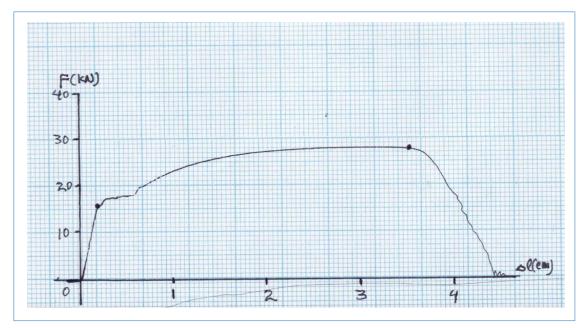
Figure 2 Force (F) and added length (Δ L) unbent samples (10-0-1)

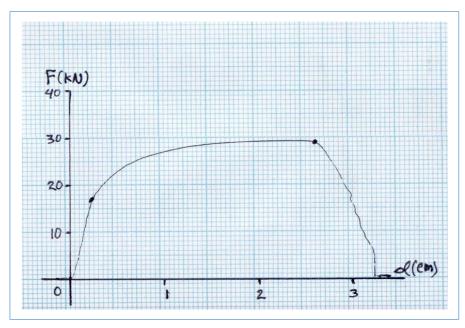
Figure 3 Force (F) and added length (Δ L) once bent samples (10-0-1)

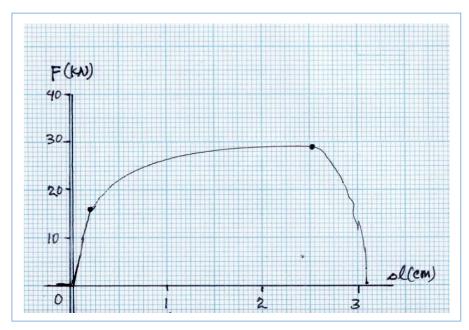
Figure 4 Force (F) and added length (Δ L) of twice bent samples (10-0-1)

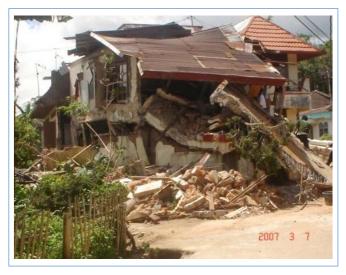
Figure 1 One of the collapsed houses in the research

Many buildings including hotels, offices and homes collapsed after the West Sumatra earthquake on 30 September 2011 (Figure 1). Most the collapsed buildings were made of brick. Therefore the Department of Civil Engineering, Faculty of Engineering at the State University of Padang (UNP) and Japan International Corporation Agency (JICA) decided to conduct research into the quality and characteristics of bricks used by the West Sumatra community. Brick samples were taken from brick factories (in burning stoves) and collapsed buildings in the Padang–Pariaman area. Tests were conducted in the Material Testing Laboratory Department of the Civil Engineering Faculty of Engineering at the State University of Padang.

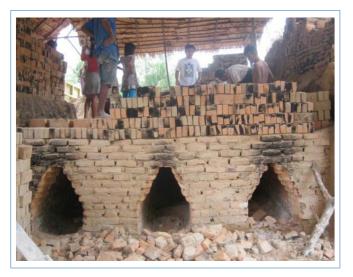
Figure 3 Bricks from a burning stove

Eighteen further samples were taken from two stoves from a brick factory at Rimbo Kalam, Lubuk Alung Sub district (Figure 3). Three samples were taken from each of three places for each burning stove: near the stove, in the middle of the stove and far from the stove.

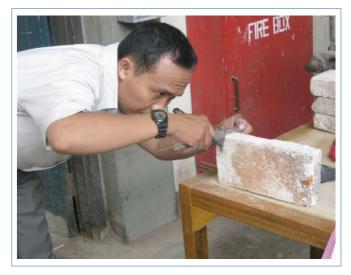
Figure 4 Measuring a brick sample

A sample must be measured by ruler to ensure squared sides (Figure 4).

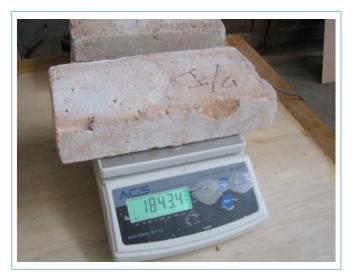
Figure 5 UNP Research Team Weighing Brick Sample

A sample must be weighed digitally in the Material Testing Laboratory Department of Civil Engineering, Faculty of Engineering at the State University of Padang (Figure 5).

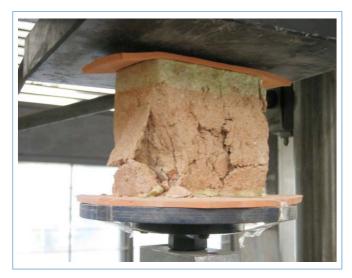
Figure 6 Compressive strength test

Compressive Strength should be tested using the Universal Testing Machine (UTM) and the 2kg/cm2/s speed test (Figure 6).

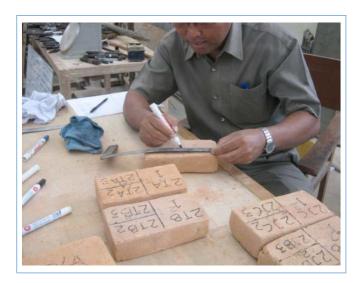
Figure 7 Factory brick sample

The brick sample should be cut into two pieces, with one piece cut again into two to produce three pieces. The total sample should comprise 144 pieces. The compressive strength is force divided by the sample area (Figure 7).

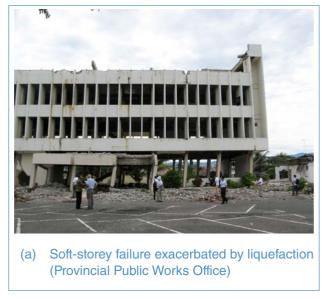
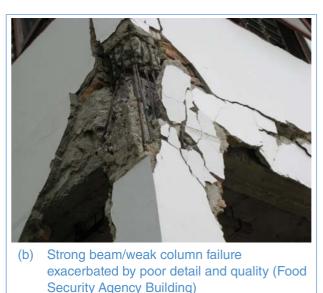
Figure 1 Typical public sector building failures

Many public buildings collapsed through the soft-storey syndrome, exacerbated by poor reinforcement detailing, especially at the joints, and poor quality concrete (Figure 1).

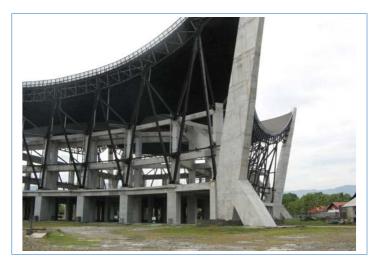
Figure 2 Mosque under construction, surviving intact

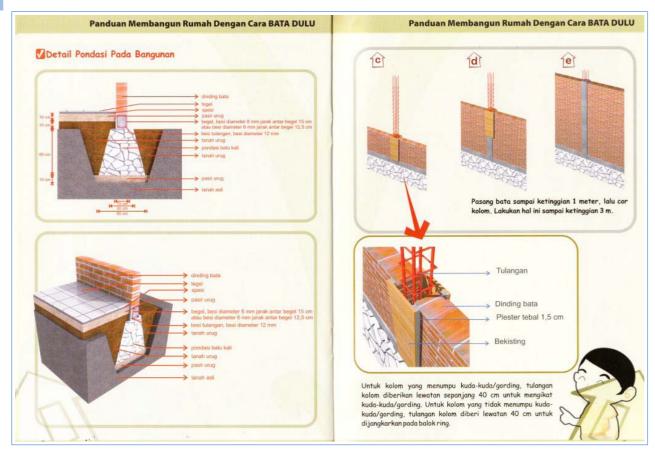
Figure 4 Extract of the Manual for Reconstruction after an Earthquake (Suryabrata et al., 2007)

The most common form of building back better with masonry dwellings consists of incorporating masonry into a light reinforced concrete frame comprising columns, a cap beam on top of the wall and a plinth beam at the bottom. An example of this is the Manual for Reconstruction after an Earthquake (Suryabrata et al, 2007) developed through collaboration between the local communities and the University of Gadjah Mada, in particular after the 2006 Yogyakarta earthquake. Figure 4 shows pages from this publication indicating how concrete-column construction is integrated into brick laying. Of equal importance to the dissemination of this methodology is training builders in construction methods.

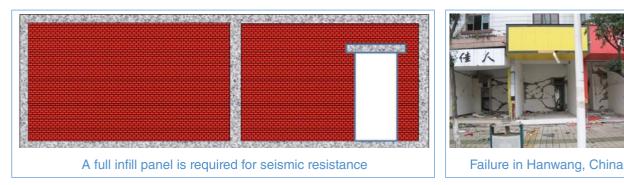
Figure 5 Seismic resistance weakened by openings

The effect of openings in masonry walls is illustrated in Figure 5. If there is no fully infilled panel in line with the panel with openings, the resistance to lateral earthquake forces is severely compromised. This is illustrated

by the failure of a condominium in Hanwang, China, during the Wenchuan earthquake, where every cross wall at ground floor level was pierced by a doorway.

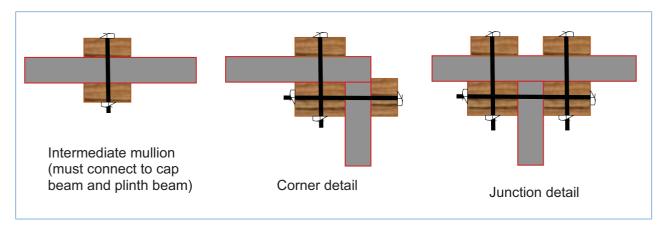
Figure 6 Strengthening of existing masonry constructions with timber posts and beams

The challenge is to adapt the concept of light ductile moment resisting framing to existing masonry housing. It is not possible to insert reinforced concrete beams and columns into existing masonry. Grundy (2010) has proposed a methodology for "strapping on" columns to walls in need of constraint. This can be achieved with timber (Figure 6) or reinforced concrete (Figure 7). If timber is used, the interface between the timber and brick must be grouted or bonded. In addition to these added columns, cap beams and plinth (base) beams (not illustrated here) are required to complete the structural framing, with proper connections between the vertical and horizontal components.

It should be immediately apparent that the house framing systems illustrated in Figures 6–7 will require training or retraining of bricklayers and other workers if they are to be executed properly. Even more challenging is the educational component – raising community awareness of the need for retrofitting. This requires the engagement of non-governmental organizations, the provincial government and village leaders in the programme.

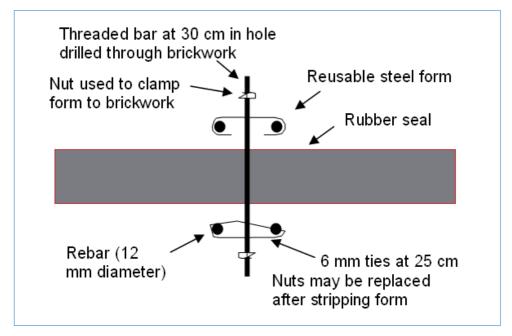
Figure 7 Strengthening of existing masonry construction with reinforced concrete posts and beams

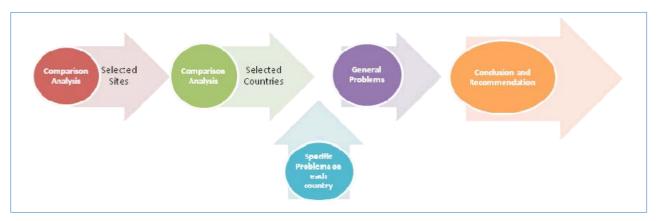
Figure 5 Data analysis flowchart

Third, the data for each site in each country was compared, using the parameters available on the data sheet. This comparison was based on average value, smallest value, largest value, most used/available or item availability. These results were compared with general construction conditions in each country to obtain representative information. The information for each country was then compared to find possible similarities and differences. Specific problems for each country were summarized, based on the survey results and surveyors' common experiences. In this way, general problems were extracted from the specific problems. Finally, conclusions and recommendations were produced regarding better techniques for improving nonengineered construction in developing countries.

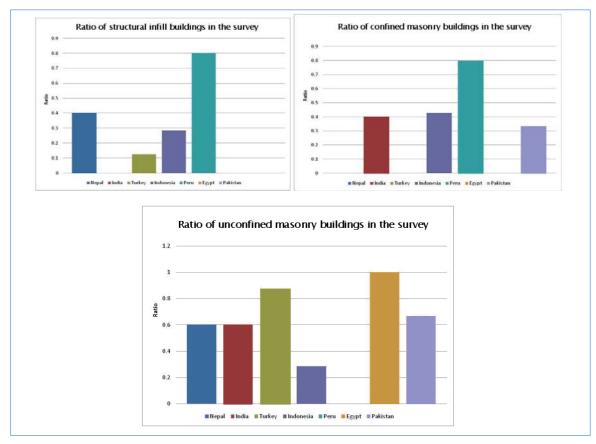
Figure 19 Proportion of different types of structure in the survey

- For confined masonry, most buildings use reinforced concrete confinement.
- The most commonly used material for doors and windows frames is wood. Only a few buildings use metal frames.
- Most of the non-engineered constructions in developing countries are unconfined masonry, except in Indonesia and Peru, where confined masonry is more popular.

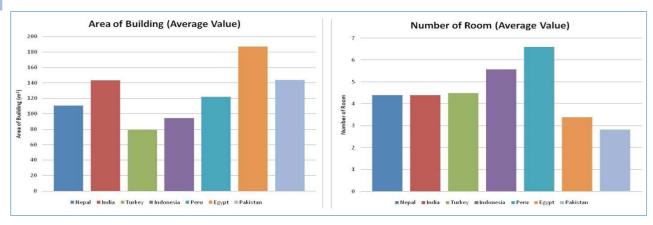
Figure 20 Average building size (left) and number of rooms (right)

- The building size depends on its main function, varying between 80 m2 and 187 m2 on average.
- The typical number of rooms varies between countries.

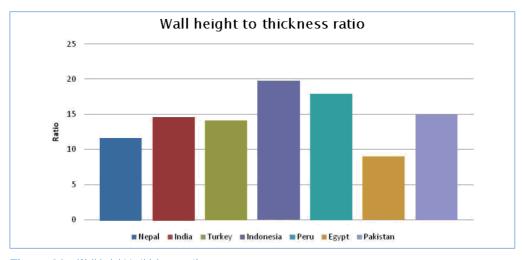
Figure 21 Wall height to thickness ratio

- Strip and isolated pad (the simplest foundation system) is found in non-engineered constructions. Various materials, such as stone and reinforced concrete, are used. Turkey has the highest strip foundation width (0.8 m), while India and Peru have the smallest (0.4 m). Turkey has the deepest foundation depth (1–2 m), while Egypt has the shallowest (0.7 m).
- Indonesia has the highest wall height to thickness ratio (19.83), while Egypt has the smallest wall height to thickness ratio (9.00). The higher the value, the weaker the wall.

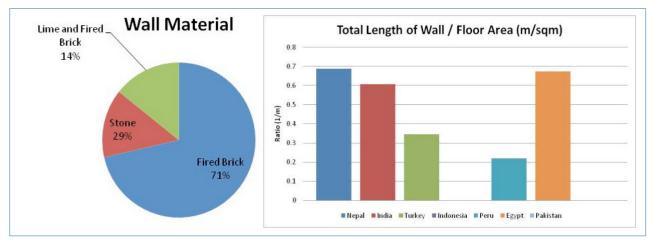
Figure 22 Wall materials (left), and total wall length and floor area (right)

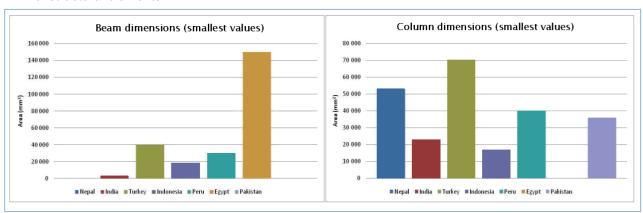
Figure 23 Beam dimensions (left) and column dimensions (right)

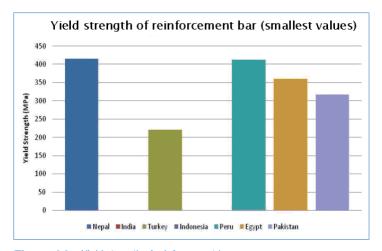
Figure 24 Yield strength of reinforcement bar

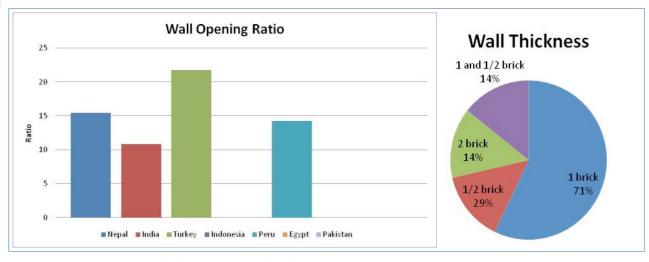
Figure 25 Wall opening ratio (left) and wall thickness (right)

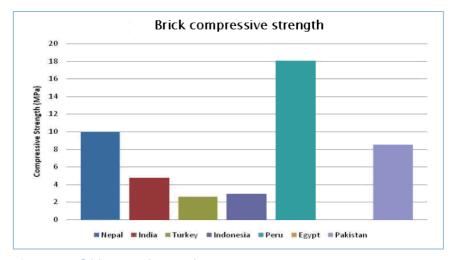
Figure 26 Brick compressive strength

- Most non-engineered constructions in the selected countries use baked clay or stone masonry for the walls.
- Indonesia, Nepal, Pakistan, Peru and Turkey use the same brick size, while Egypt and India use a different size
- Peru has the highest brick compressive strength compared to the other countries, while Turkey has the smallest brick compressive strength.

• The data gained from Egypt was rather strange, because the data sheet stated that the compressive strength of bricks was around 100 MPa, which is higher than the strength of high-performance concrete.

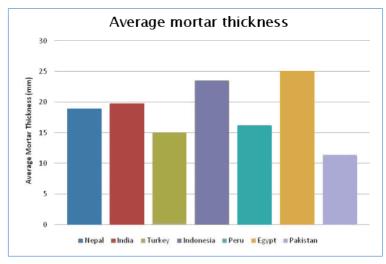
Figure 27 Average mortar thickness

- Based on the results of testing in each country, some selected sites have inadequate brick strength.
- Most of the countries use ordinary Portland cement as the plaster, and mortar as the cementing agent.
- Mortar strength is higher in Pakistan than other countries, even though they use the same composition. The exception is Peru, which uses a different mortar composition (1:02) but produces the same compressive strength.
- Egypt has the thickest layer between bricks (25 mm), while Turkey and Pakistan have the thinnest (10–20 mm and 11.45 mm respectively).

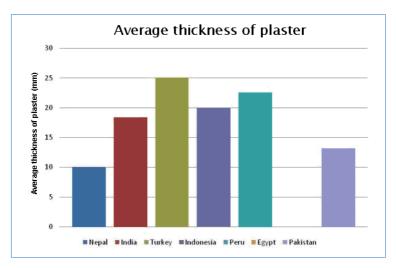
Figure 28 Average thickness of plaster

- The common plaster composition is either 1:6 or 1:4, except in Peru where the composition is 1:1.
- Turkey has the thickest layer of plaster (20–30 mm), while Nepal has the thinnest (10 mm).

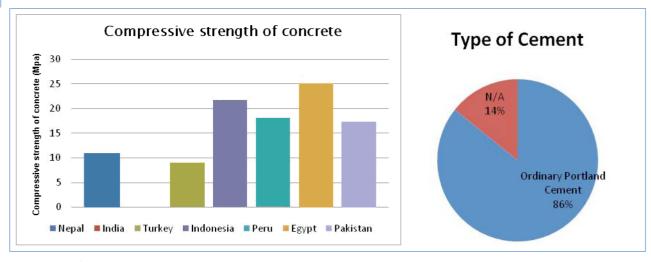
Figure 29 Compressive strength of concrete and type of cement

- Based on the surveys conducted in selected countries, some of the non-engineered constructions use very poor concrete strength for the structural elements.
- Indonesia has the highest compressive strength concrete (21.75 MPa), while Turkey has the smallest (8–10 MPa).
- All of the countries use ordinary Portland cement in constructions.
- Most of the aggregates are taken from rivers and mountain quarries.
- India, Nepal and Pakistan use 1 part cement to 2 parts sand and 4 aggregates in the mixing composition, while Indonesia uses 1 part cement, 2 parts sand and 3 aggregates. Peru uses 1 part cement to 1.2 parts sand and 4 aggregates in the mixing composition. The mixing composition in Indonesia and Peru results in a relatively high compressive strength.
- In some countries, workers on some sites do not use any measurements when mixing concrete.

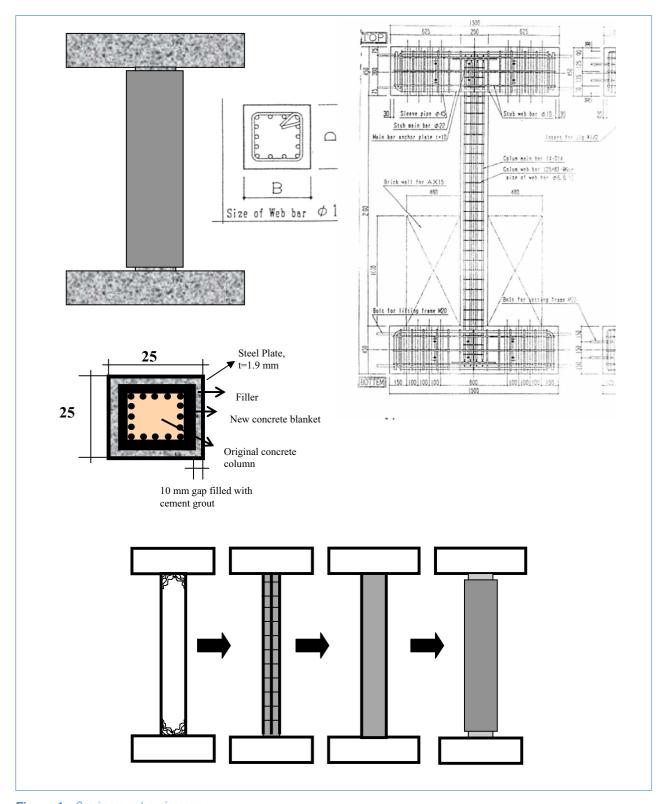
Figure 1 Specimens and repair process

Figure 1 shows the original and repaired column specimens, along with the repair process. The column section measured W $25 \text{ cm} \times \text{L} 25 \text{ cm} \times \text{H} 210 \text{ cm}$. The height from the base to the loading point was 280 cm. The shear span ratio was 4.2. 13 mm diameter bars were arranged as longitudinal reinforcements with a 3 per cent ratio. As hoop reinforcements, 6 mm diameter hoops were arranged at intervals of 9 cm, and the ratio of web bars was 0.25 per cent.

When the steel jacket was applied to the specimens to be repaired, two steel plates, each with a thickness of 1.9 mm were bent into a channel shape. Both channel-shaped steel plates were set up around the column and than welded into a jacket. To avoid jacket from axial stress, a vertical gap of 1 cm was left between both ends of the steel plate and a stab of column specimen, as shown in Figure 1.

Two column specimens were tested, one subjected to an axial load of 35.5 Tf and the other an axial load of 69.4 Tf. This load was constantly applied together with a lateral load. After the first load had damaged the column specimens, a steel jacket was used to repair them, and both repaired column specimens were then reloaded using the same procedure.

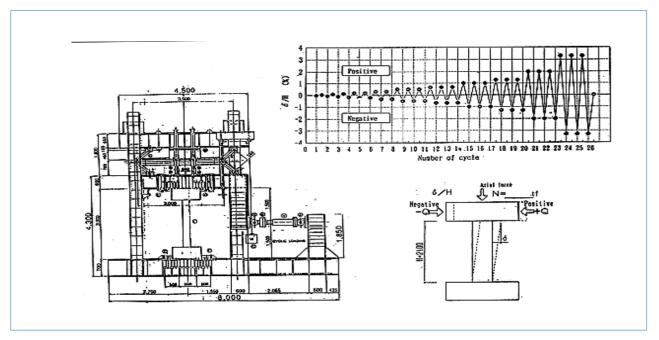
Figure 2 The loading position of the specimens and loading pattern

The horizontal load on the test specimen was applied through the L-shaped beam by a 300 Tf capacity actuator. The vertical load was applied by a 300 Tf capacity actuator installed on the upper beam of the steel reaction frame. A 350-tonne capacity roller bearing was placed between the frame and actuator to follow the horizontal displacement of the specimen.

Force was applied horizontally with gradually increasing displacement according to the loading process shown in Figure 2. A constant axial load was applied, including the weight of the loading apparatus, to produce an axial stress.

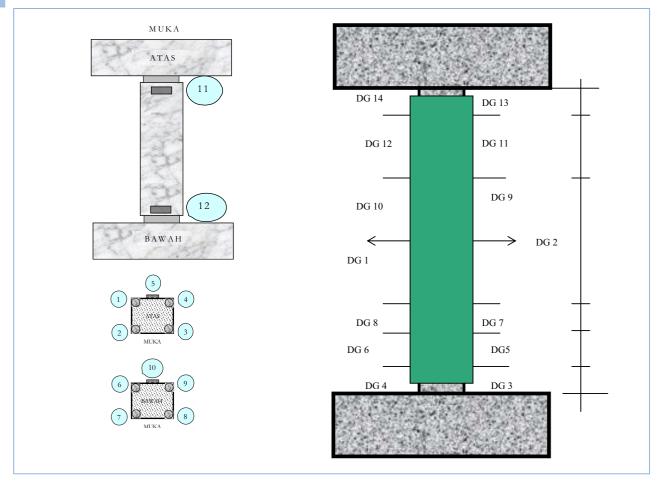
Figure 3 Location of strain gauge and dials gauge

Displacement transducers measured the displacement of each part of the test specimen with a 25 mm capacity, placed in the measurement frame fixed to the surface of the test specimen. Also, to clarify the specimen failure mode, the strain in the axial direction at the top and bottom of the column's main bar causing the maximum bending moment was measured with a one-axis strain gauge (5 mm detection length). For the strengthened specimen, strains at the main point of the steel plate were measured with three-axis strain gauges. The strain measurement positions are shown in Figure 3. The displacement and strain data was obtained using a digital strain measurement device and recorded with online control by computer.

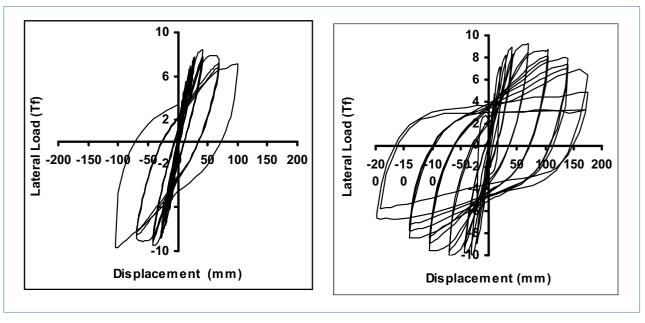
Figure 4 Hysteresis loop curve of original and repaired column specimens

The hysteresis loop curve of the column test is depicted in Figure 4, which shows that the ductility and strength of the repaired specimens can recover much more effectively than the original specimens. The ductility capacity of repaired specimen No. 2 (SJBU 2), which was subjected to an axial load of 69.4 Tf, was lower compared with repaired specimen No. 1 (SJBU 1), which was subjected to an axial load of 35.5 Tf. In addition to the lateral load capacity, the lateral load capacities that could be achieved were lower for repaired specimen No. 2 than repaired specimen No. 1. The area of each hysteresis loop in each cycle of the repaired specimens was much larger than in the original specimens. The ultimate displacement was shorter for repaired specimen No. 2 than repaired specimen No. 1. In general, the enhancement effect of steel plate for recovering damaged columns can be seen through the deference of the hysteresis loops area, as shown in Figure 5.

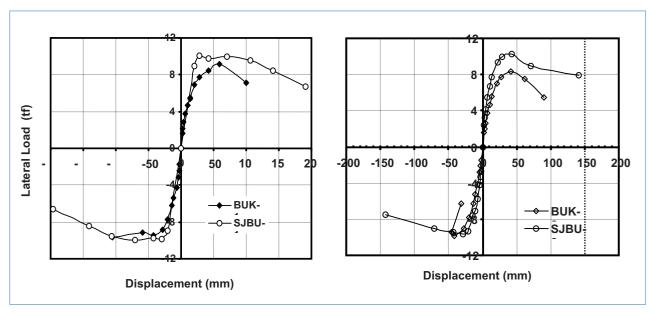
Figure 5 Load-deformation envelope curve

The curve in Figure 5 represents the load-deformation envelope curve for each test specimen. Figure 7a is a combination envelope curve showing the original and repaired column in specimen test No. 1, which was subjected to a load of 35 per cent of its axial load capacity. Figure 7b is a combination envelope curve showing the original and repaired column for specimen test No. 2 with a load of 50 per cent of its axial load capacity. The envelope of specimen BUK-1 and SJBU-1 shows the confinement effect of steel plate on the property improvement of repaired column specimen. This effect could be examined from increasing the load as first crack, yield point; maximum load and ultimate horizontal displacement were achieved.

When compared with the original specimen (BUK 1), increases of 56 per cent, 12 per cent, 8.4 per cent and 48 per cent were obtained for the first load, yield point, maximum load and ultimate displacement respectively. For specimens No. 2 (BUK-2 and SJBU-2), the confinement effect of the steel plate was slightly smaller than for specimen No. 1 (SJBU 1), since the axial load applied to the column of specimen No. 2 was much larger than the axial load applied to the column specimen No. 1 (SJBU 1). Examined from the test result of repaired specimen No. 2 (SJBU 2) and then compared with the original specimen No. 2 (BUK 2), increases of 33 per cent, 24 per cent, 19 per cent and 36 per cent were obtained for the first load, yield point, maximum load and ultimate displacement respectively.

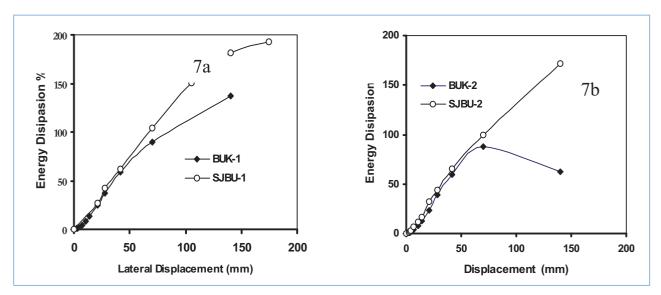
Figure 7 Impact of the steel plate jacket on energy absorption

Figure 7 compares the specimens with regard to accumulated energy absorption. Energy absorption in each loading step was computed here by integrating the relevant hysteresis loop. Figure 7a shows that in the case of original specimen BUK 1, which was subjected to an axial load of 35.5 Tf, the energy absorption in each loading step began to decrease as the lateral displacement reached 50 mm. At this point, displacement tof he core concrete of the column started to suffer from damage. In the case of repaired specimen SJBU 1, the impact of the steel jacket for recovering column performance was shown by extending further and stable of the energy absorption up to the ultimate displacement reached. Figure 7b shows the impact of the steel jacket on improving the energy absorption of the reinforced concrete column, which was confirmed by repaired column specimen SJBU 2, which was subjected to an axial load of 69.4 Tf. The energy absorption of the original column started to decrease and radically drop when the displacement reached 50 mm. On the other hand, in the repaired specimen, the energy absorption rose in a stable manner until ultimate displacement was achieved.

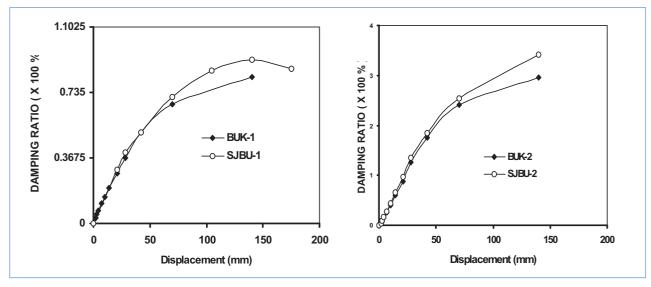
Figure 8 Impact of the steel plate jacket on equivalent damping ratio

Figure 8 shows the impact of the steel jacket on the equivalent damping ratio. The ratio calculated was based on the hysteresis loop in the first loading cycle of each loading step. The ratio of the repaired column SJBU 1 and SJBU 2 rose constantly as lateral displacement increased, while the ratio of the original specimen began

to decrease at the lateral displacement of 50 mm. This indicated that stable damping performance was obtained with the steel jacket method.

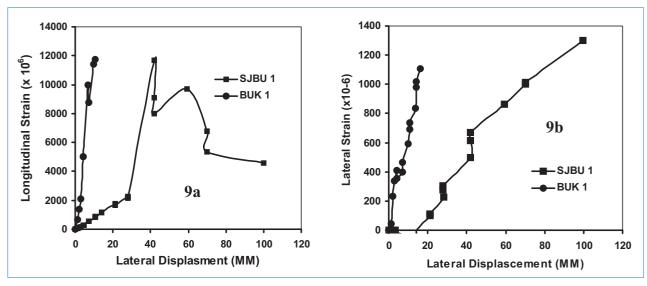
Figure 9 Impact of steel plate on hoop strain and longitudinal reinforcement

The effectiveness of the steel plate confinement can be seen from the strain performance of the main bar and hoop in both the original and repaired columns. Figure 9a compares BUK 1 and SJBU 1 with regard to the strain of longitudinal bars, showing that the strain produced in the longitudinal bars of SJBU 1 was smaller at every loading step, with the steel jacket functioning as a longitudinal reinforcement. In addition to the web bars of the column, the steel jacket functioned effectively as a hoop reinforcement limiting the lateral deformation of the concrete column. This is shown in Figure 9b, in which the strain of web bar in SJBU 1 was much weaker than the strain in the original column.

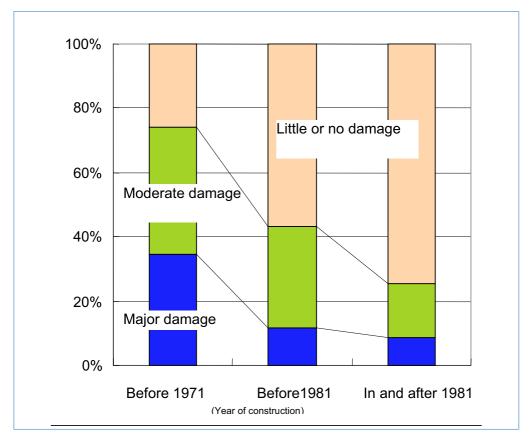
Figure 2 The degree of damage to buildings by construction year

Building codes are considered the most effective tools to safeguard the lives and property against major disasters, particularly earthquakes. Figure 2 shows the degree of damage to buildings by construction year. There are clear differences in the damage to buildings constructed before 1971, between 1971 and 1981, and after 1981.

The Building Standards Law of Japan (BSL) was amended to strengthen reinforced-concrete standards in 1971, and New earthquake resistant standards were introduced in 1981. This analysis provided an important fact: a strict building code is an effective means to reduce earthquake damage.

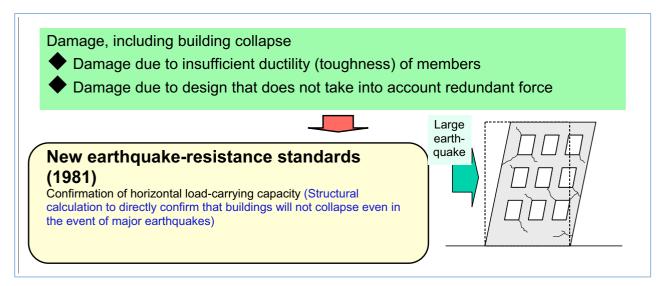
Figure 3 New earthquake resistance standards

The new standards have a two-tier target for structural design. First, buildings should not be damaged by medium-scale earthquakes, or Intensity 5 quakes on the Japanese scale, which occur infrequently. Second, the building should not collapse or fall due to large-scale earthquakes, or Intensity 6–7 quakes on the Japanese scale, which occur very rarely. Simply put, the standard requires "no damage by medium load and no collapse by large load". According to this principle, provisions for the confirmation of horizontal load-carrying capacity were introduced in the seismic code.

Before the enactment of the New earthquake resistant standards in 1981, structural requirements were for buildings to suffer no damage from medium-sized earthquakes. It was believed that buildings would withstand even large earthquakes thanks to high ductility.

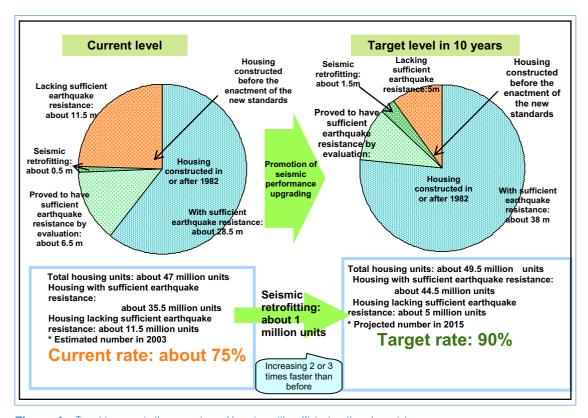
Figure 4 Target increase in the percentage of housing with sufficient earthquake resistance

In 2006, MLIT set a target to raise the proportion of housing and specified buildings with sufficient earthquake resistance in the basic principles to 90 per cent by 2015 from the current 75 per cent.

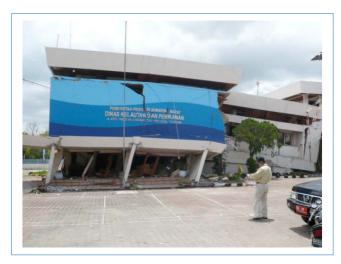
Figure 9 Damage to buildings due to the soft-storey mechanism

A rigid partition on a floor may also affect differences in stiffness of a floor. The large difference can also cause the soft-storey mechanism, which is one cause of severe damage or collapse in the 2009 Pariaman earthquake. Figure 9 shows examples of buildings that collapsed due to the soft-storey mechanism.

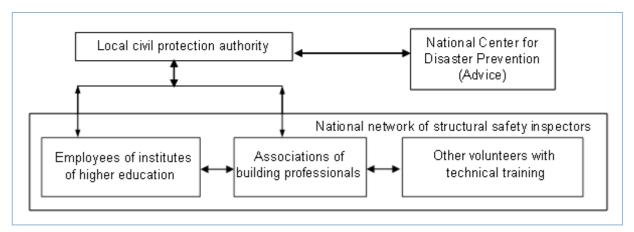
Figure 3 Scheme of the protocol of response for RENE

- 3. A response protocol has been proposed to identify the level of structural safety of existing buildings, as well as their structural stability following a disruptive event causing damage and requiring an assessment of urban infrastructure. This protocol is shown in Figure 3.

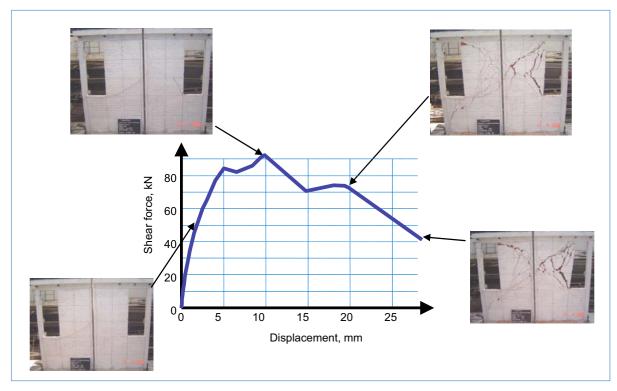
Figure 4 Relationship between observable damage and remaining strength

To estimate the remaining strength and deformation capacity of buildings assessed after a severe earthquake, information is used from experimental research to establish a relationship between the level of observable damage and remaining strength, as shown in Figure 4.

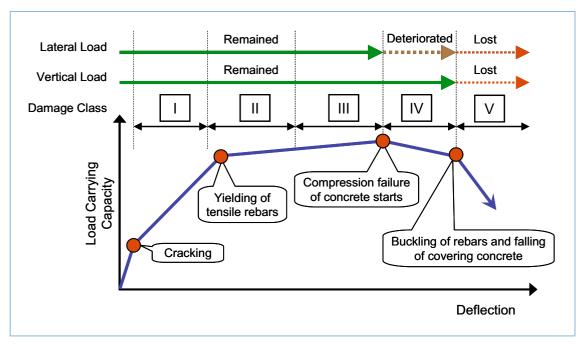
Figure 5 Relationship between observable damage and remaining strength

Based on the information and concepts above, criteria and benchmarks are established, as indicated in Figure 5. This information is necessary to define the remaining strength and therefore the structural safety of buildings.

The remaining strength of the entire structural system can be determined, based on the resistance of individual structural elements, taking into account resistance deterioration due to irregularities in plan and/or elevation, as well as the location of the damaged elements within the structure.

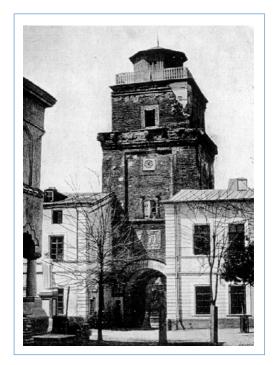
Figure 2. Coltea Tower (photo © Szathmary, 1869)

During the 1802 earthquake, many bell and church towers collapsed in Bucharest and several churches were destroyed there, including the Cotroceni monastery and Saint Spiridon Church. Half of Coltea tower collapsed and the remainder was seriously damaged (Figure 2). Most wealthy residences were heavily damaged and some collapsed. In Brasov, many chimneys collapsed, and houses and churches were damaged. The earthquake was felt in Transylvania, Sibiu, Sighisoara and Banat in Timisoara, as well as in Poland, Bulgaria, Turkey and Russia. In Cernauti, some houses were damaged. In Lvov, the Armenian church cracked and the bells rang by themselves, while light damage occurred even in Moscow.

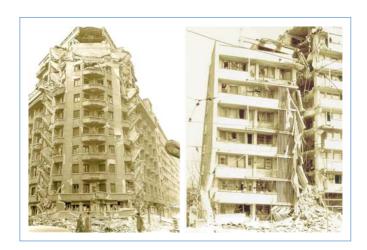
(i) The Wilson building, built in the 1930s (ii) The Lizeanu building, built in the 1960s

Figure 7 Soft-storey collapse of the building at ground level

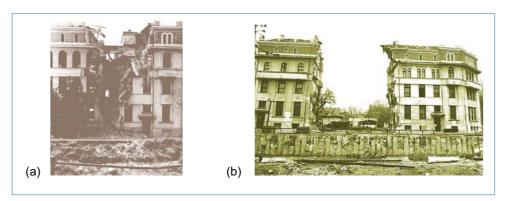
Figure 8 Bucharest, 4 March 1977: heavy damage to two University buildings built at the end of the nineteenth century. (a) Effect of bombing during the Second World War – (b) 1977 earthquake impact on the Faculty of Chemistry (photo © UTCB D. Lungu)

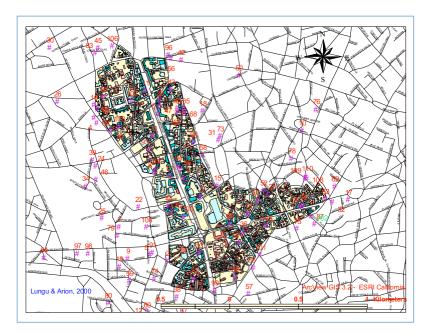
Figure 9 Map of central Bucharest with vulnerable buildings built prior to 1945 and identified as having the highest risk of collapse in the event of a strong earthquake (Mw≥7.5)

The explanation for the city centre location of the most fragile or vulnerable tall reinforced-concrete buildings in Bucharest as well as 29 (of 32) tall reinforce-concrete buildings that collapsed during the 1977 earthquake comes from the Urban Development Plan issued in 1935 by the Municipality of Bucharest. The plan recommends the city centre for the tallest buildings (i.e. buildings with 6–7 full storeys plus 2–3 setback storeys, with a roof height smaller or equal to street width). The collapse of buildings in the centre of Bucharest is clearly explained by the lack of mass vertical-symmetry, lack of structure horizontal-regularity, accumulated damage during the 1940 earthquake, low-strength concrete (mean compressive strength of ≤200 daN/cm2), soft ground floor due to commercial use (no in-filled masonry walls) and dynamic characteristics. Presently, 127 tall reinforced-concrete buildings built before the Second World War were randomly identified by authorities and structural engineers as "Seismic Risk Class 1" buildings (i.e. buildings likely to collapse or be very severely damaged during the next earthquake similar or larger to the 1977 event, as shown in Figure 9). The number of fragile high-rise reinforced-concrete buildings in the centre of Bucharest is probably double the existing number of buildings identified as Seismic Risk Class 1, as many of the most vulnerable buildings in the city centre are still not yet identified as being very vulnerable. In spite of the high cost of adequately retrofitting the fragile reinforced-concrete high-rise buildings located in the centre of Bucharest, there are

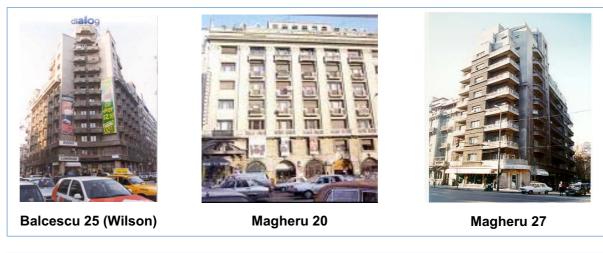
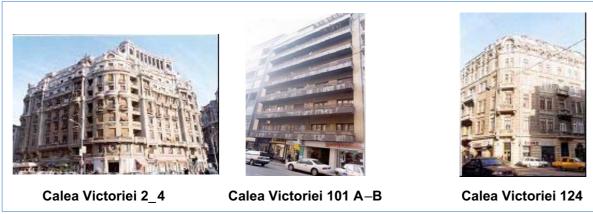
Figure 10 Architectural heritage buildings in central Bucharest: examples of tall RC buildings built before 1940 in the city centre

Ten years after the creation of the consolidation programme for Class 1 seismic risk buildings, 19 of the initial 127 entries on the list (buildings over four storeys) are located on the Calea Victoriei and Magheru and Bălcescu boulevards (Figure 10). Most of them are considered part of the city's architectural heritage:

- 10 buildings (5 above 7 storeys) are fully consolidated
- 6 buildings (4 above 8 storeys) are under consolidation
- 12 buildings (7 above 7 storeys) have prepared plans for consolidation

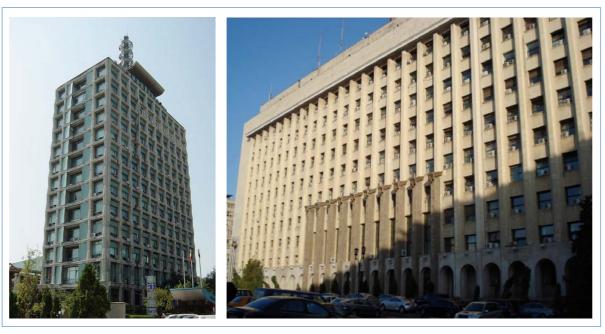
Figure 11 (a) National Romanian Television building, and (b) a reinforced-concrete flexible building built in the 1960s and the Ministry of Transport, Construction and Tourism, built in the 1930s

Taking into account the risk matrix in Table 1, even Seismic Risk Class 2 buildings but importance and exposure (Class 1 buildings must be considered Seismic Risk Class 1 buildings, for example those shown in Figure 11).

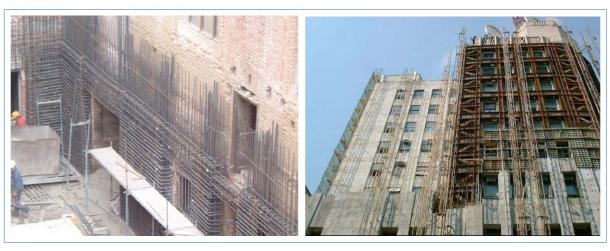
Figure 12 Retrofitting of (a) the Justice Palace, 2006, and (b) the Telephone Palace, 2002

The Historical Monuments List (prepared by the National Institute for Historical Monuments – INMI, 2004), contains 26 cultural heritage palaces in Bucharest. Among these, the following Seismic Risk Class 1 palaces might be considered for priority strengthening: (1) Multistorey steel structures: the Ministry of Transport, Construction and Tourism, (2) Multistorey reinforced-concrete structures: Romanian Government Palace and City Hall of Sector 1, Bucharest, (3) Masonry and reinforced concrete buildings: the Royal Palace or National Museum of Art of Romania (central building), etc. Only the Justice Palace and Telephone Palace are now fully retrofitted (Figure 12).
