UNESCO-IPRED-RIHS INTERNATIONAL WORKSHOP
PADANG, INDONESIA, 6-8 JULY 2010

Research Institute for Human Settlements
Agency for R&D – Ministry of Public Works of Indonesia
Provincial Government of West Sumatera
Padang, Indonesia

SURVEYS AND ACTIVITIES ON POST-EARTHQUAKE DISASTER

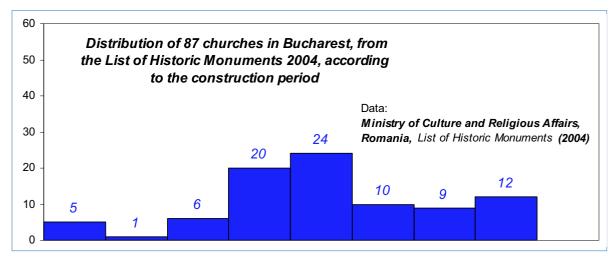
Figure 13 Distribution by age of the churches considered architectural heritage according to the list of Historical Monuments, Bucharest 2004

There are more than 200 orthodox churches in Bucharest, of which almost half are listed as architectural heritage buildings (Figure 13). Most of the old churches need structural strengthening and immediate rehabilitation.

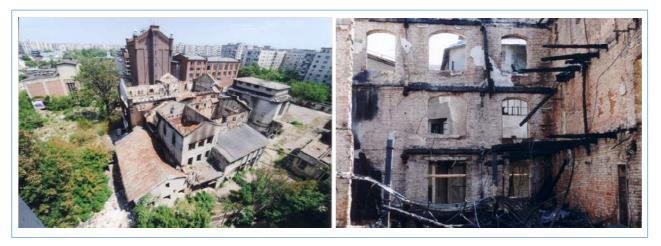
Figure 17. Arson and vandalism precipitated the self-collapse of the Asan Mill, industrial heritage, Bucharest, 1853

Asan Mill, built in 1853, is the first steam mill in Romania. It is an industrial architectural monument in category A, the 2004 List of Historic Monuments, code B-II-m-A-19692. The building is made of bearing walls with wooden boards. The mill was lewd on 14 May 2008 for a thorough and rapid extermination of the wooden boards and roof ridge. The walls show signs of vandalization of bearing walls (Figure 17).

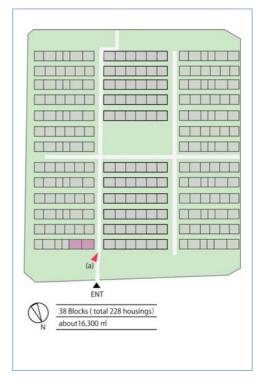
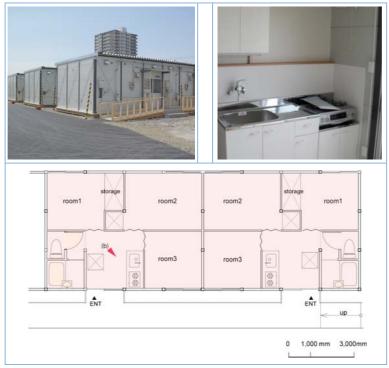
Figure 2 Temporary housing (Asuto Nagamachi), Sendai (9 May 2011)

On 20 May, 30,647 affected people were accommodated in 404 refugee units. Temporary houses were built across 16,300m2 in Sendai City (Asuto Nagamachi), consisting of 38 blocks (one block for six housing units), with the standard housing type consisting of 3K with a bath and toilet (two rooms to sleep six and one to sleep eight). Here, the temporary houses are quite industrial and not particularly personal.
